# **Effectiveness Monitoring Committee**

*Initial Concept Proposal*

## San Vicente Redwoods: Redwood Defect Pilot Study

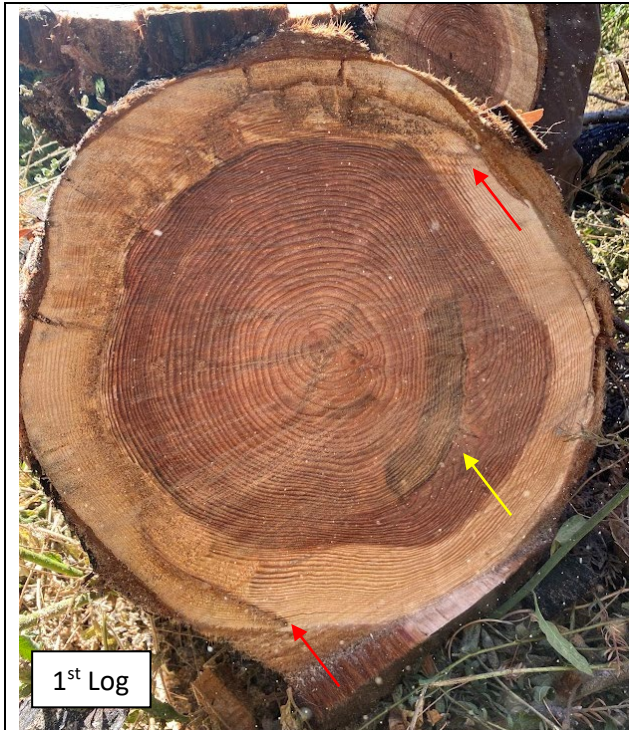
1<sup>st</sup> Log

- 1<sup>st</sup> log 18" Inside Bark (IB) – 270 bf (board feet) gross volume
- Deduct 120 bf for damage from 2020 fire  
44% deduction ( **between red arrows**)
- 150 bf net volume
- **Deductions:**
- 3" of rot from 2020 fire around 2/3 of circumference = 120 bf deduction
- Past Damage: 42 years ago (1980) (**yellow arrow**) - possible mechanical damage = 5 bf deduction
- 2<sup>nd</sup> log 13" IB – 120 bf net
- No deductions from 2020 fire
- "Stain" visible in heartwood
- 3<sup>rd</sup> log 8" IB – 30 bf net
- No defect from 2020 fire
- Top of the tree is very dry

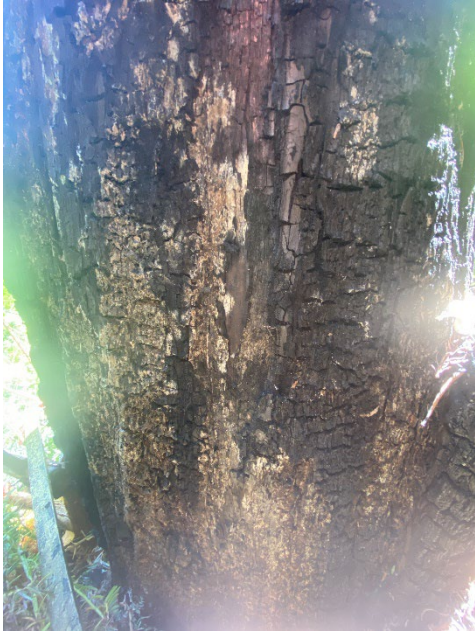
Tree #388 Coniophora Puteana

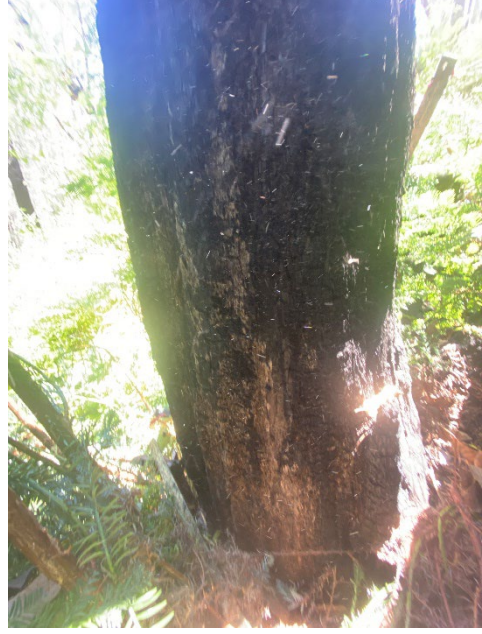
Tree #388 Coniophora Puteana

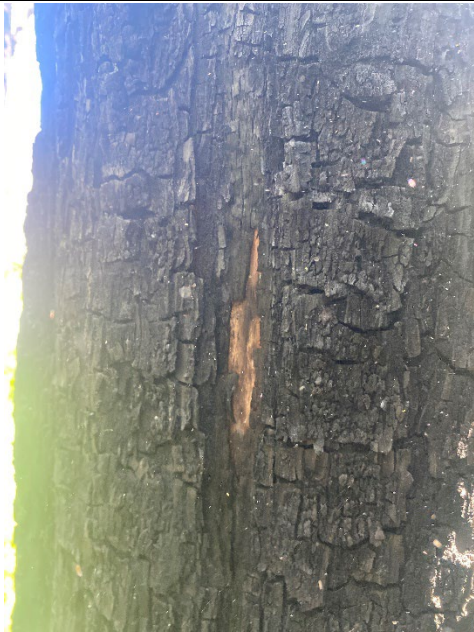
Tree #388 Burned exposed cambium

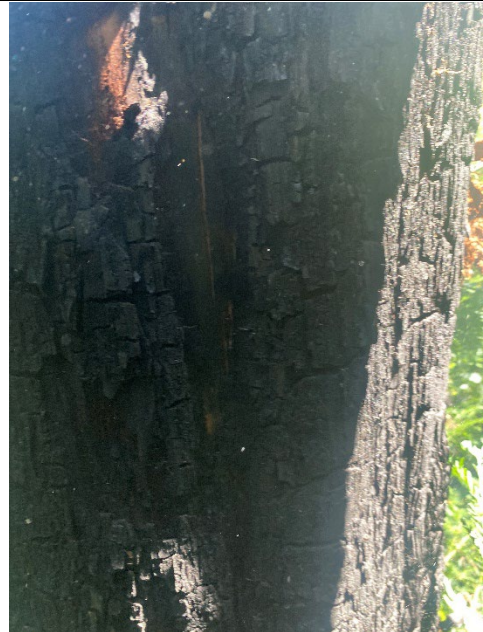
#388 Burned exposed cambium

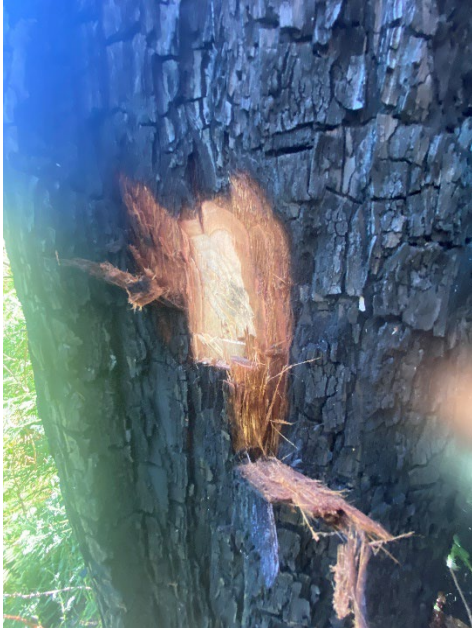
Tree #388 Manually exposed dead cambium

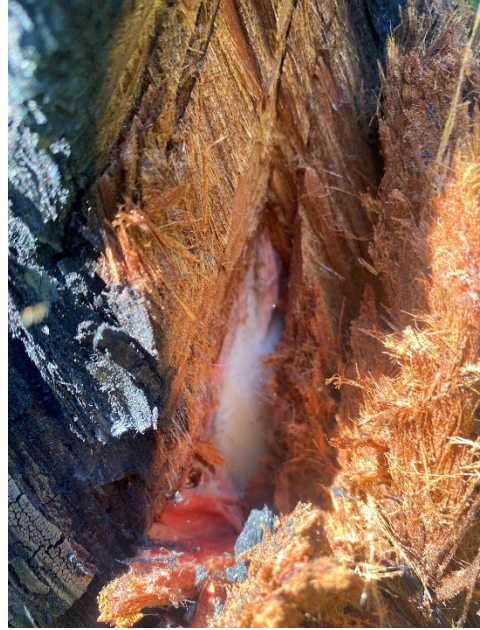
Tree #388 Manually exposed live cambium

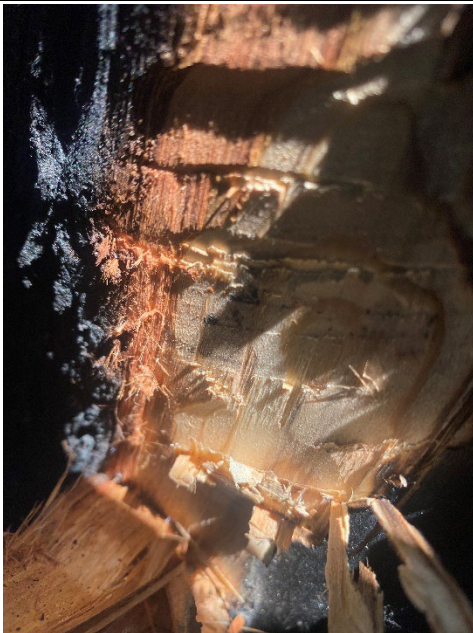
Tree #388 Manually exposed dead cambium

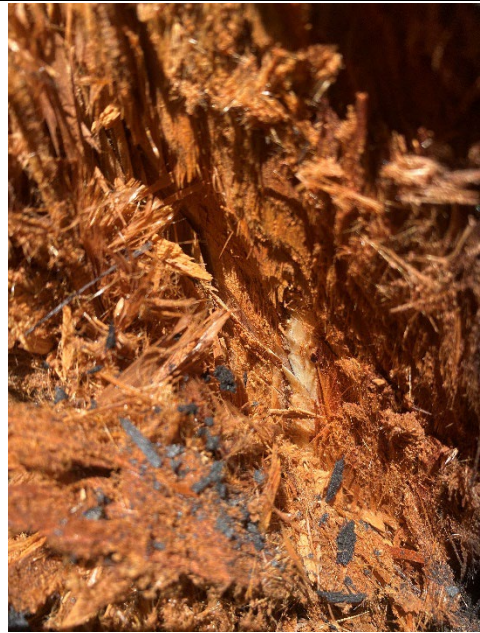
Tree #388 Manually exposed live cambium

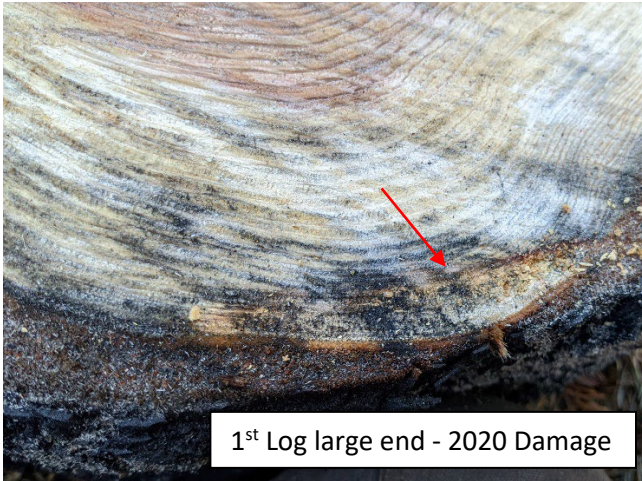
1<sup>st</sup> Log large end - 2020 Damage

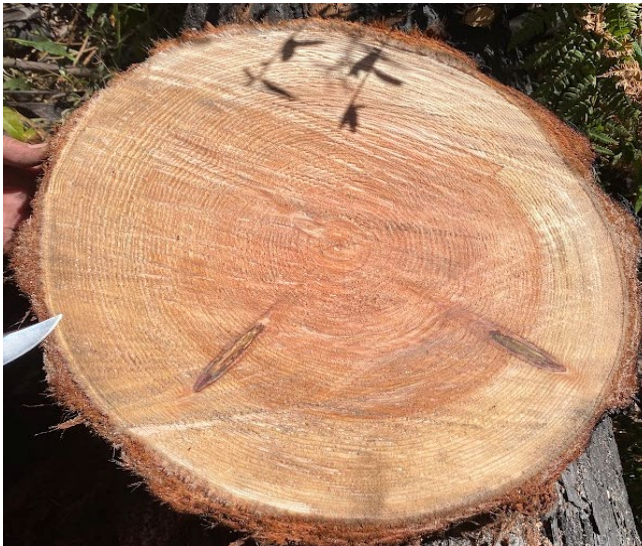
1<sup>st</sup> Log small end – No 2020 Damage, yellowing sapwood

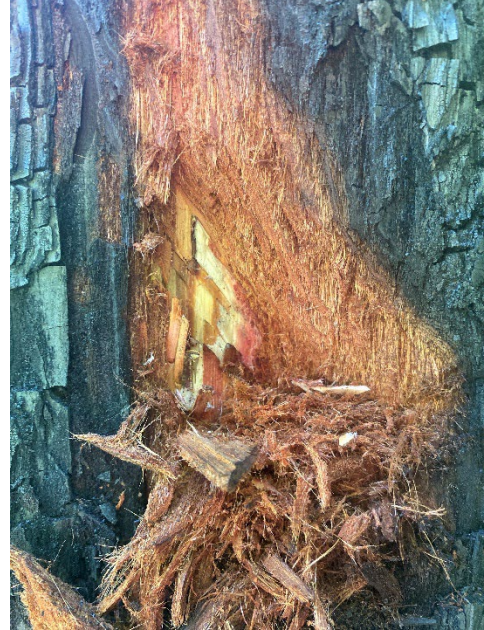
Tree #322 Manually exposed live cambium

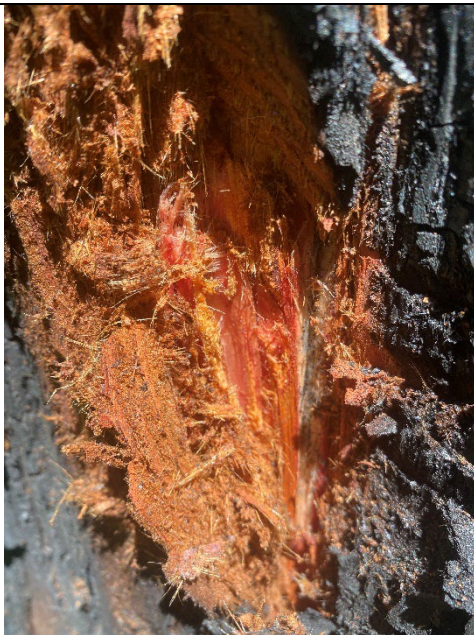
Tree #322 Manually exposed live cambium

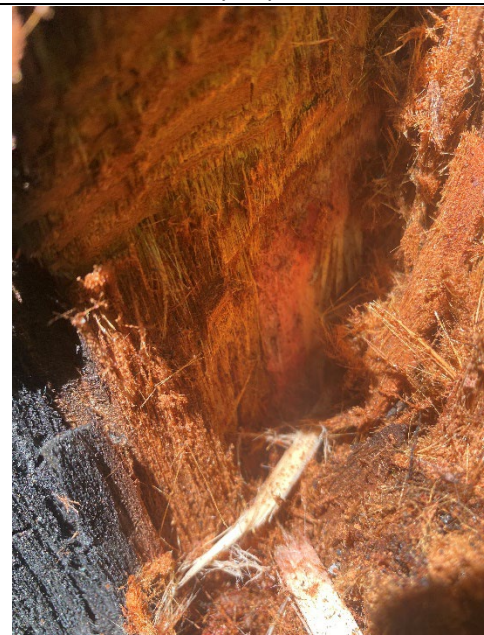
Tree #322 Manually exposed live cambium

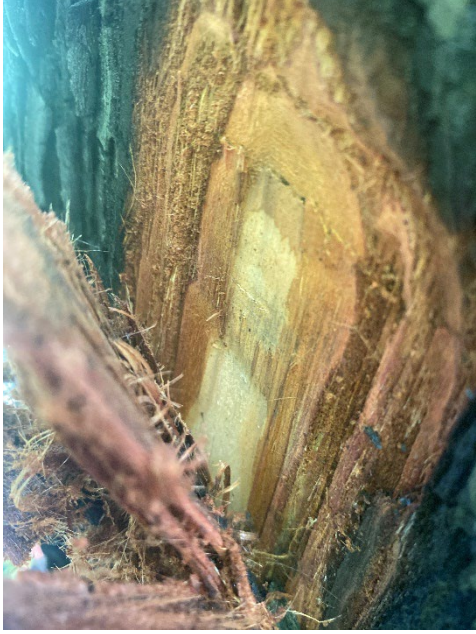
Tree #322 Manually exposed dead cambium

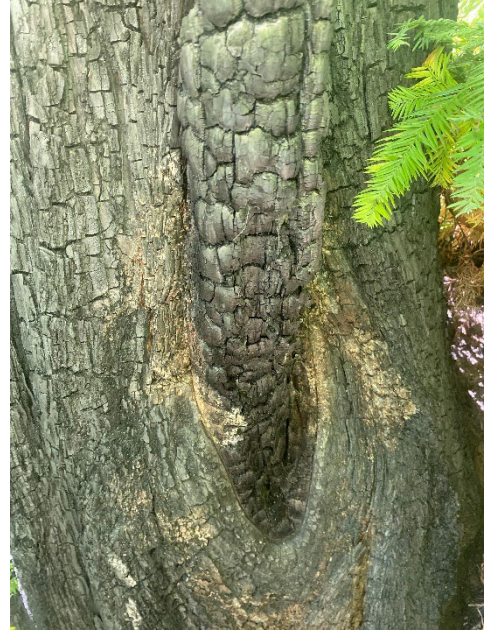
Tree #322 *Coniophora Puteana*

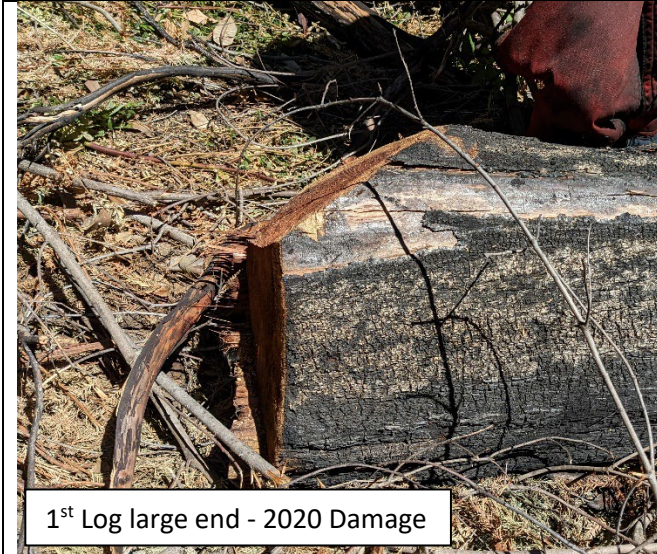
\*0% deduction due to 2020 fire damage; however damage to the cambium and very thin layer of sapwood over 1/3 of circumference on large end (red arrows) would impact future defect as the tree continues to grow and encapsulate the rot pockets.

1<sup>st</sup> Log large end - 2020 Damage

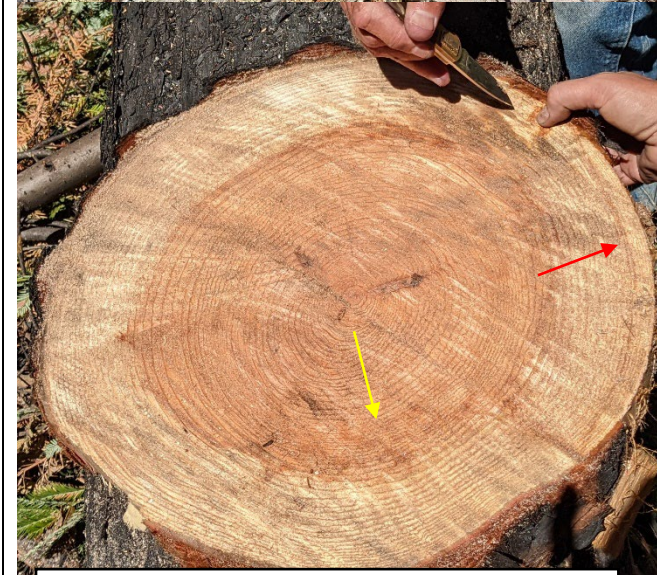
1<sup>st</sup> Log small end - 1" of rot from 2020 Fire

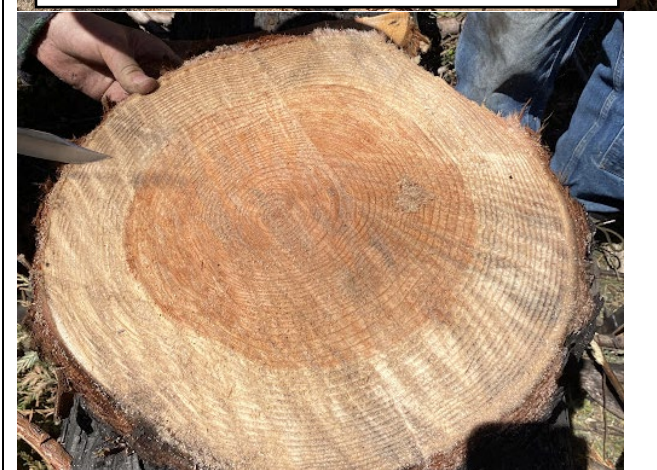
2<sup>nd</sup> Log small end – 2" of rot from 2020 Fire

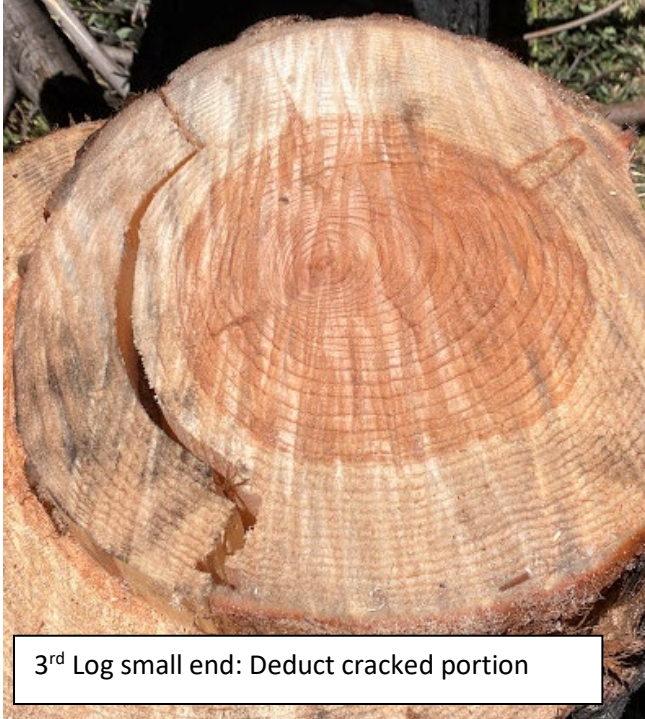
- 3<sup>rd</sup> log
- Wetter, but could be because log is sitting in the shade
- **Deductions:**
- Would deduct portion of wood that breaks apart

3<sup>rd</sup> Log small end: Deduct cracked portion

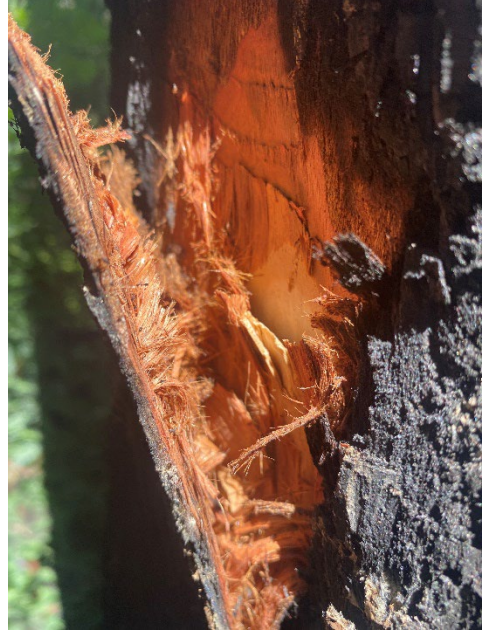
Tree #394 Manually exposed dead cambium

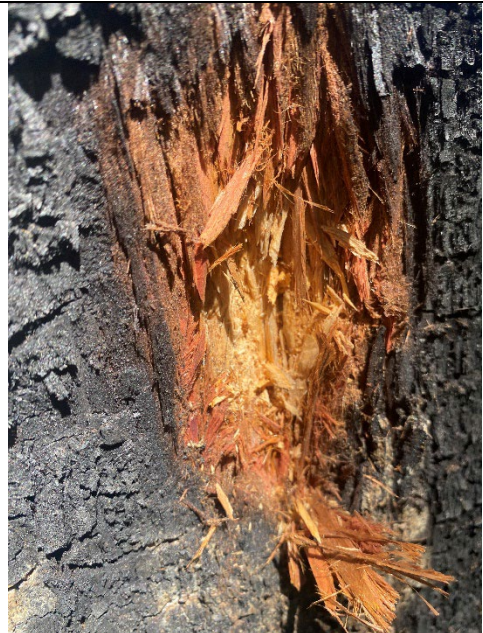
Tree #394 Manually exposed dead cambium

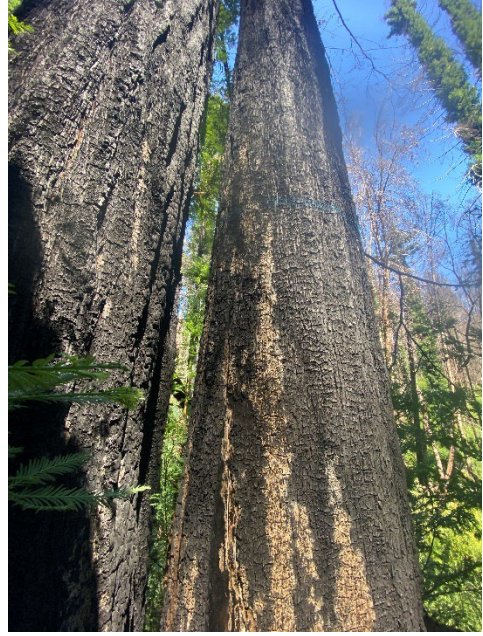
Tree #394 *Coniophora puteana*

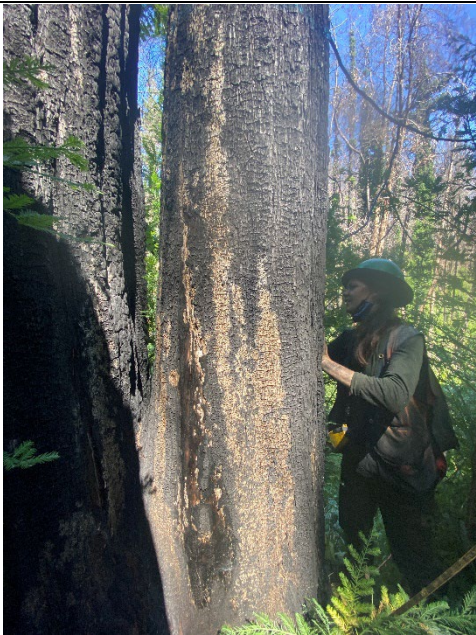
Tree #394 *Coniophora puteana*

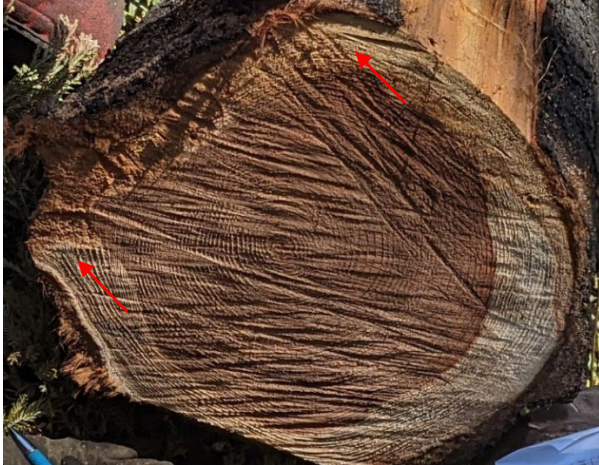
1<sup>st</sup> Log small end - 2" of rot around 1/3 from 2020 Fire

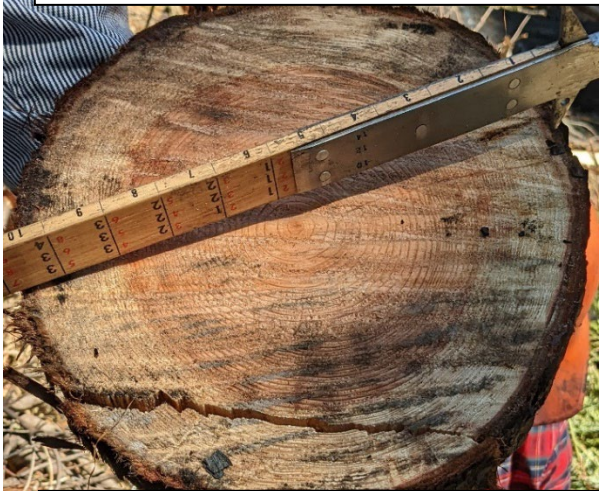
2<sup>nd</sup> Log small end – No deductions, Stain + Dry

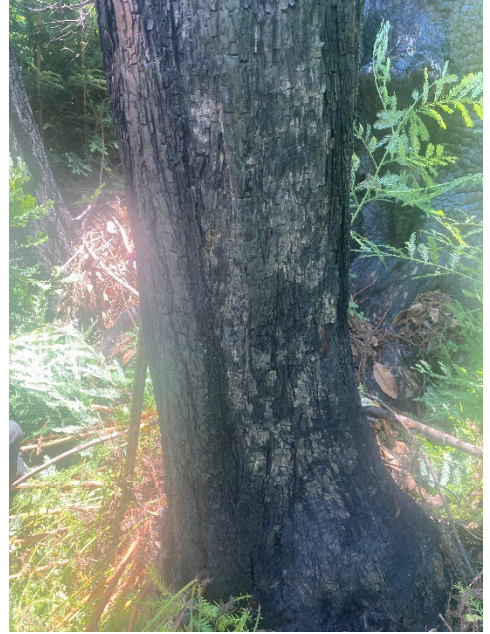
Tree #323 *Coniophora puteana*

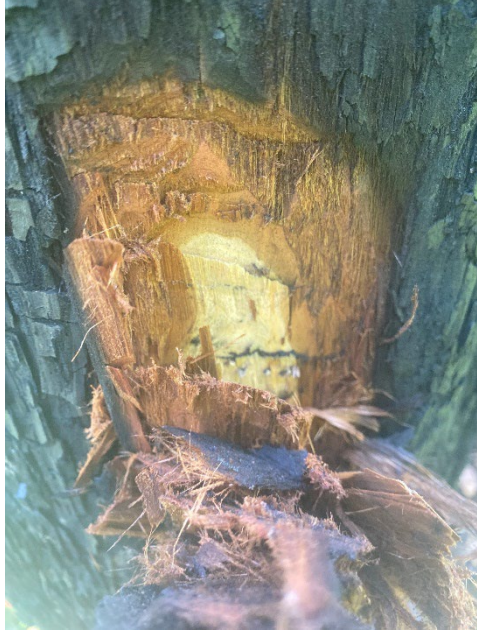
Tree #323 Manually exposed dead cambium

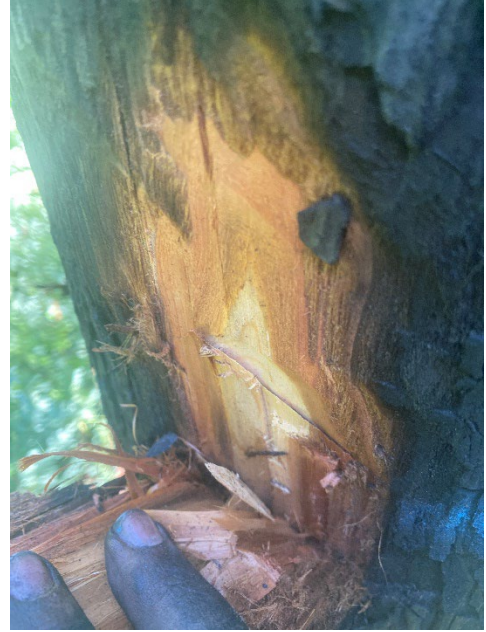
Tree #323 Manually exposed dead cambium

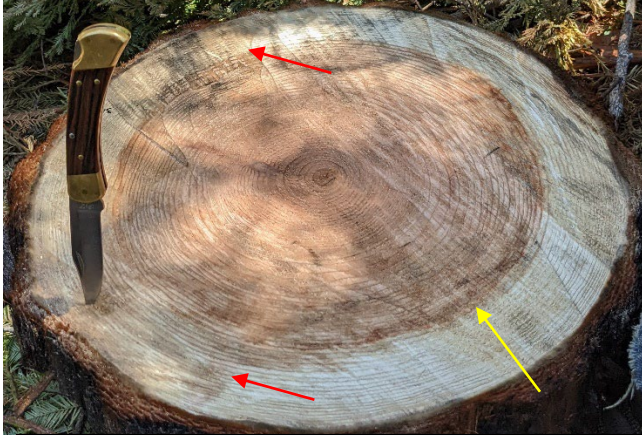
1<sup>st</sup> Log small end - 2" of rot around 1/3 from 2020 Fire

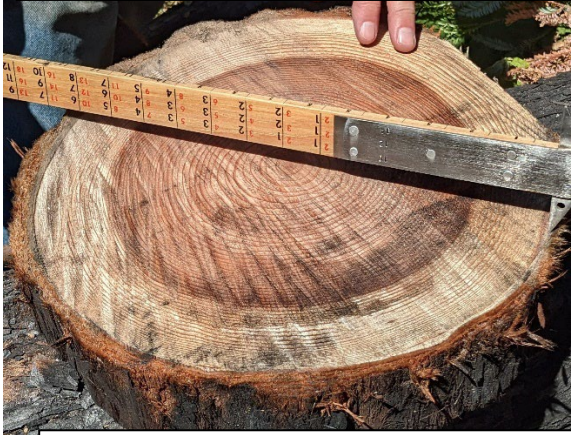
2<sup>nd</sup> Log small end – No deductions, Stain + Dry

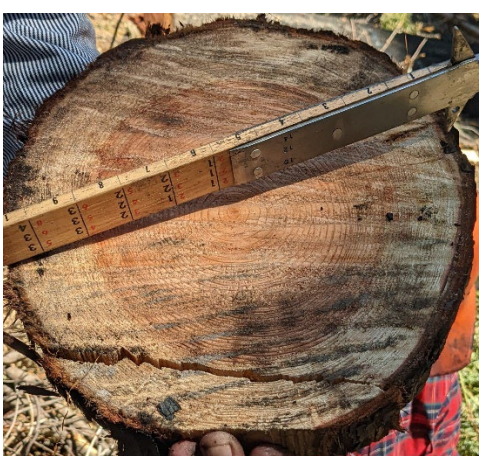
3<sup>rd</sup> Log small end – No deductions, Stain + Dry

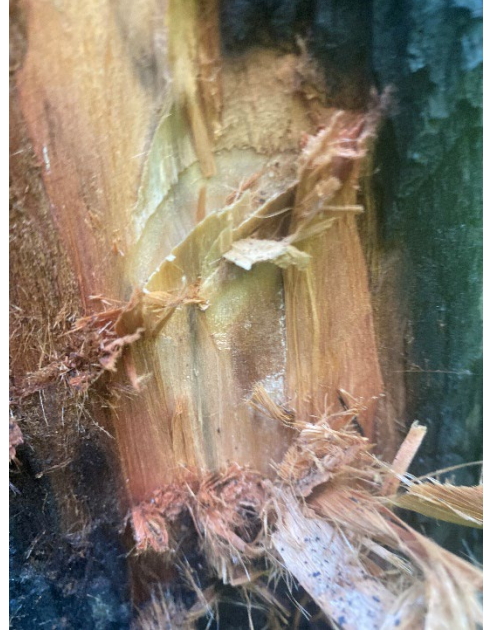
Tree #391 Manually exposed dead cambium

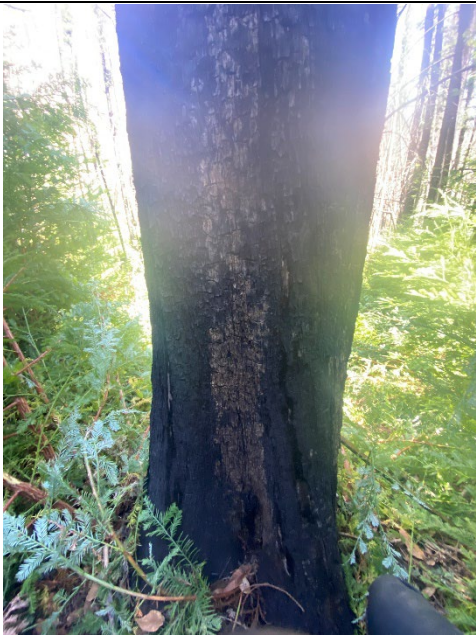
Tree #391 *Coniophora puteana*

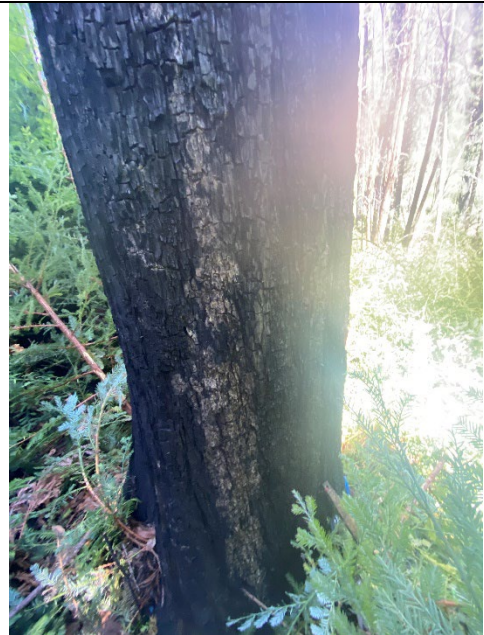
Tree #391 *Coniophora puteana*
