Briefing to the Effectiveness Monitoring Committee

California Geological Survey Studies

EMC-2016-003

Lidar Differencing Eldorado National Forest and Nearby
Private Lands

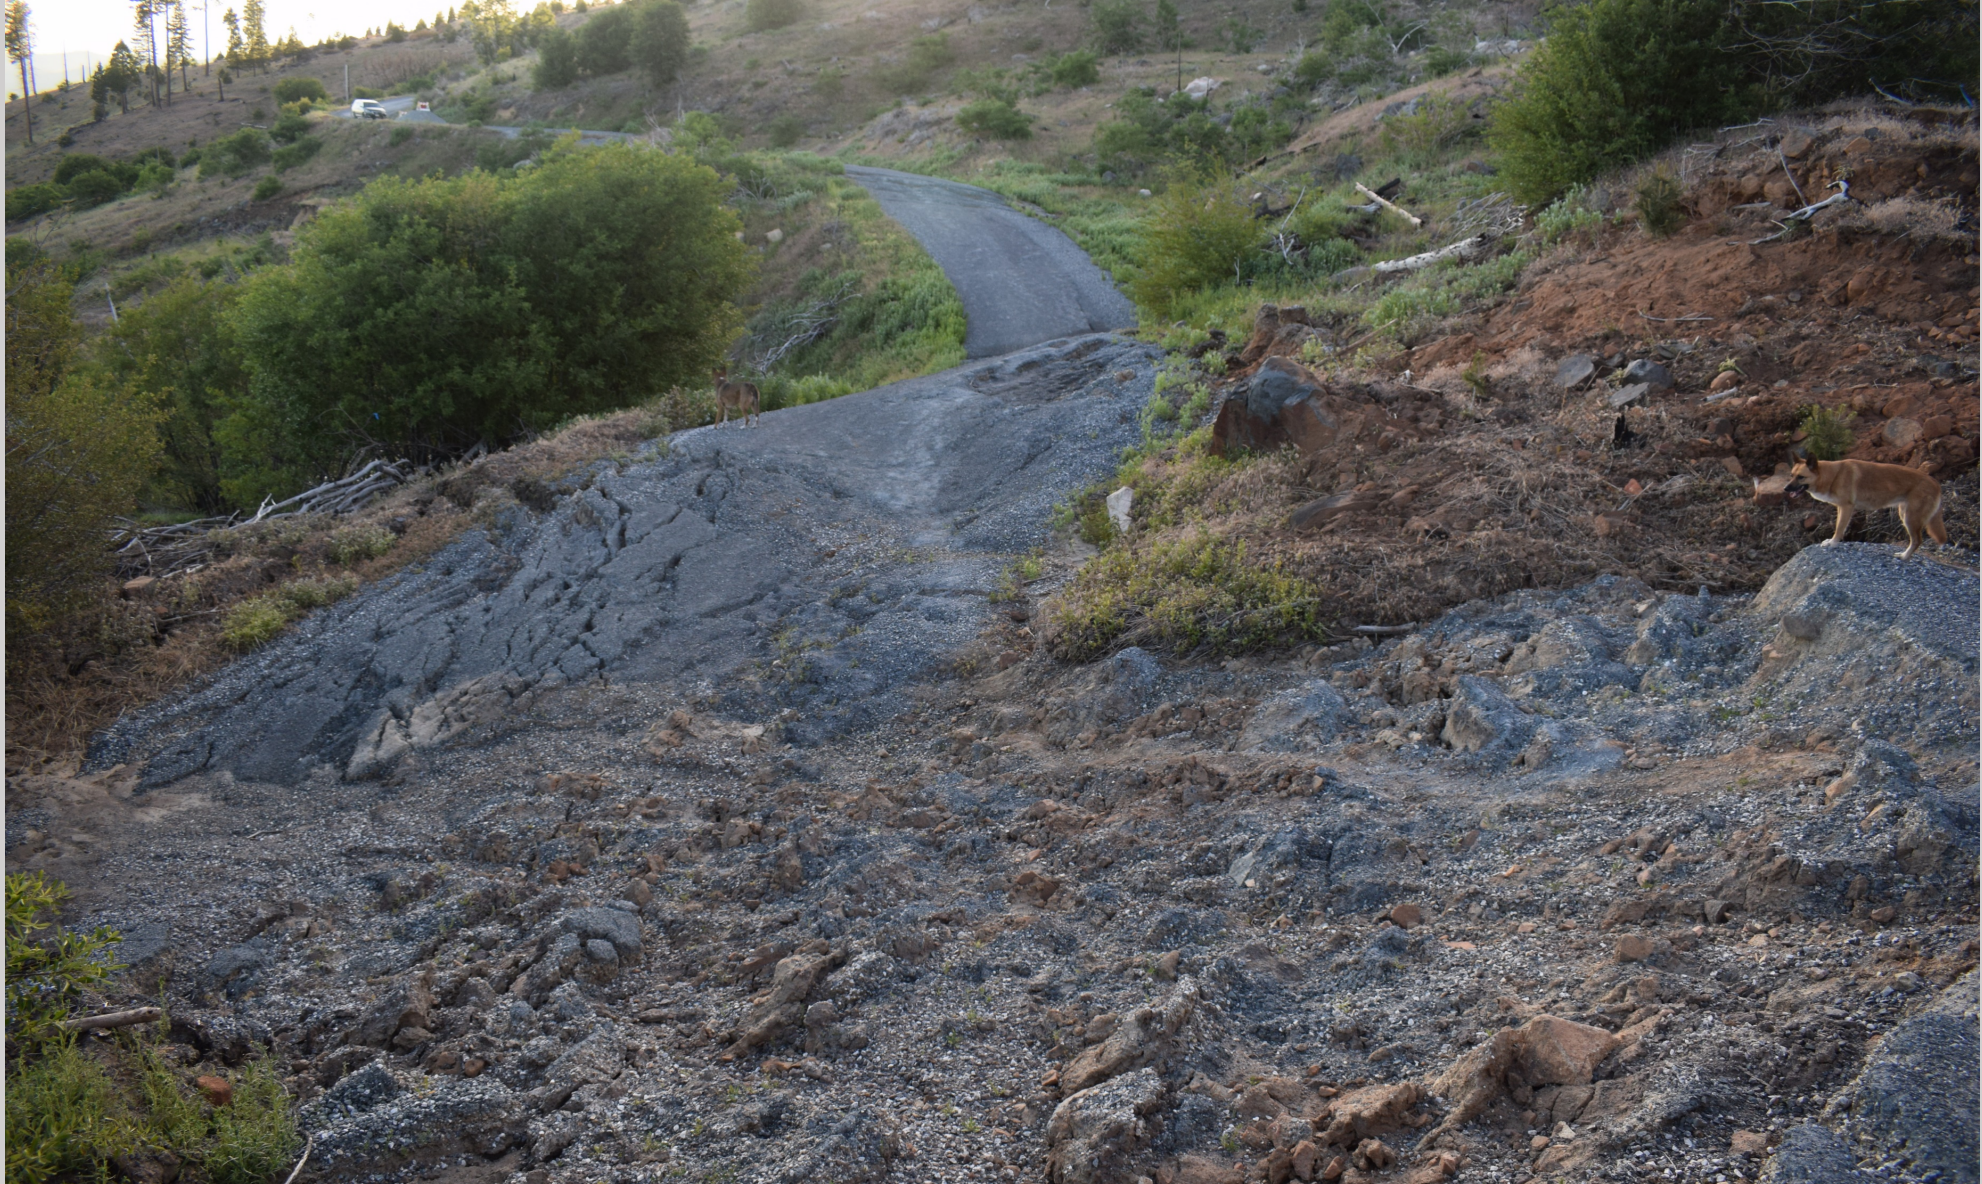
2004 Fred's Fire

Granite Springs Road

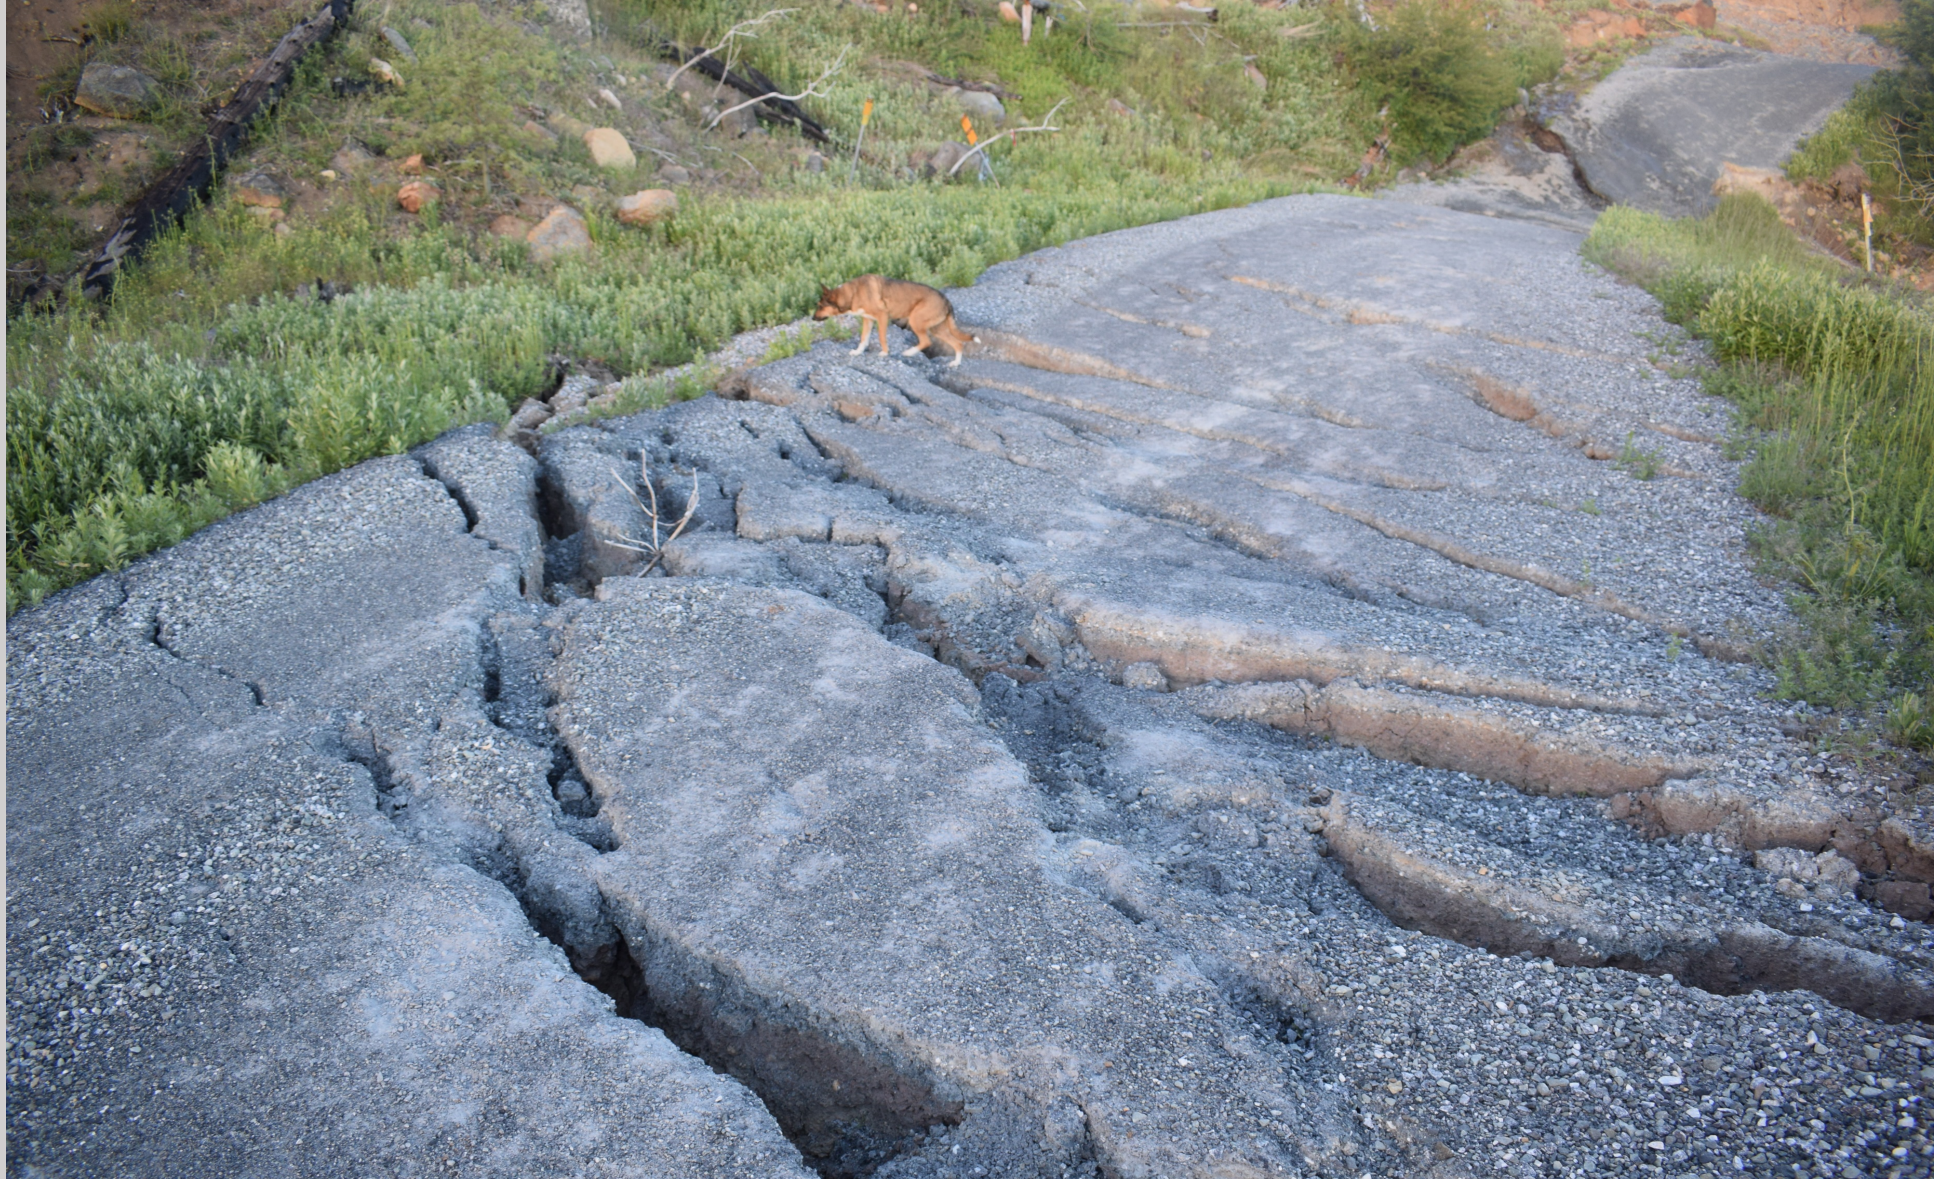
2004 Fred's Fire

Granite Springs Road

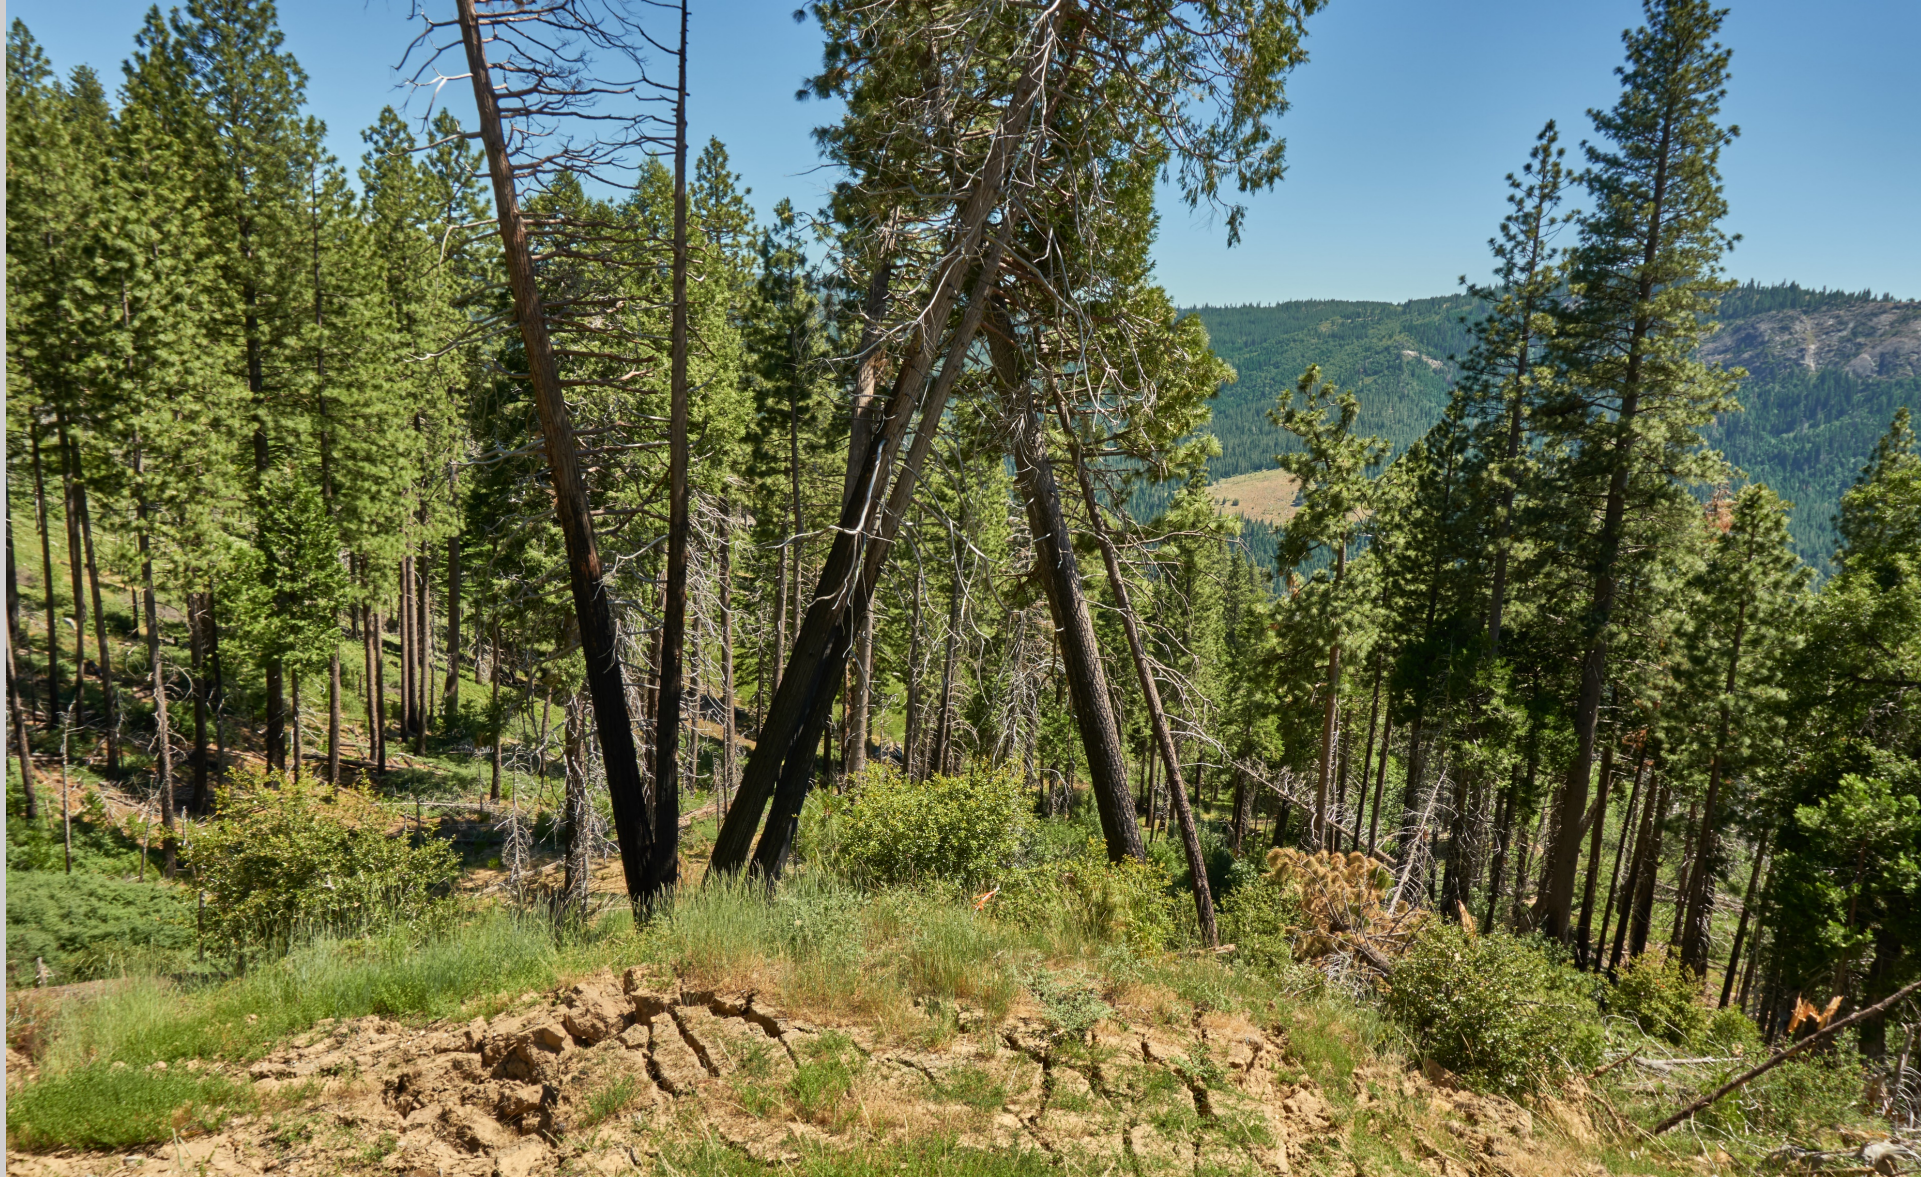
2004 Fred's Fire

Granite Springs Road

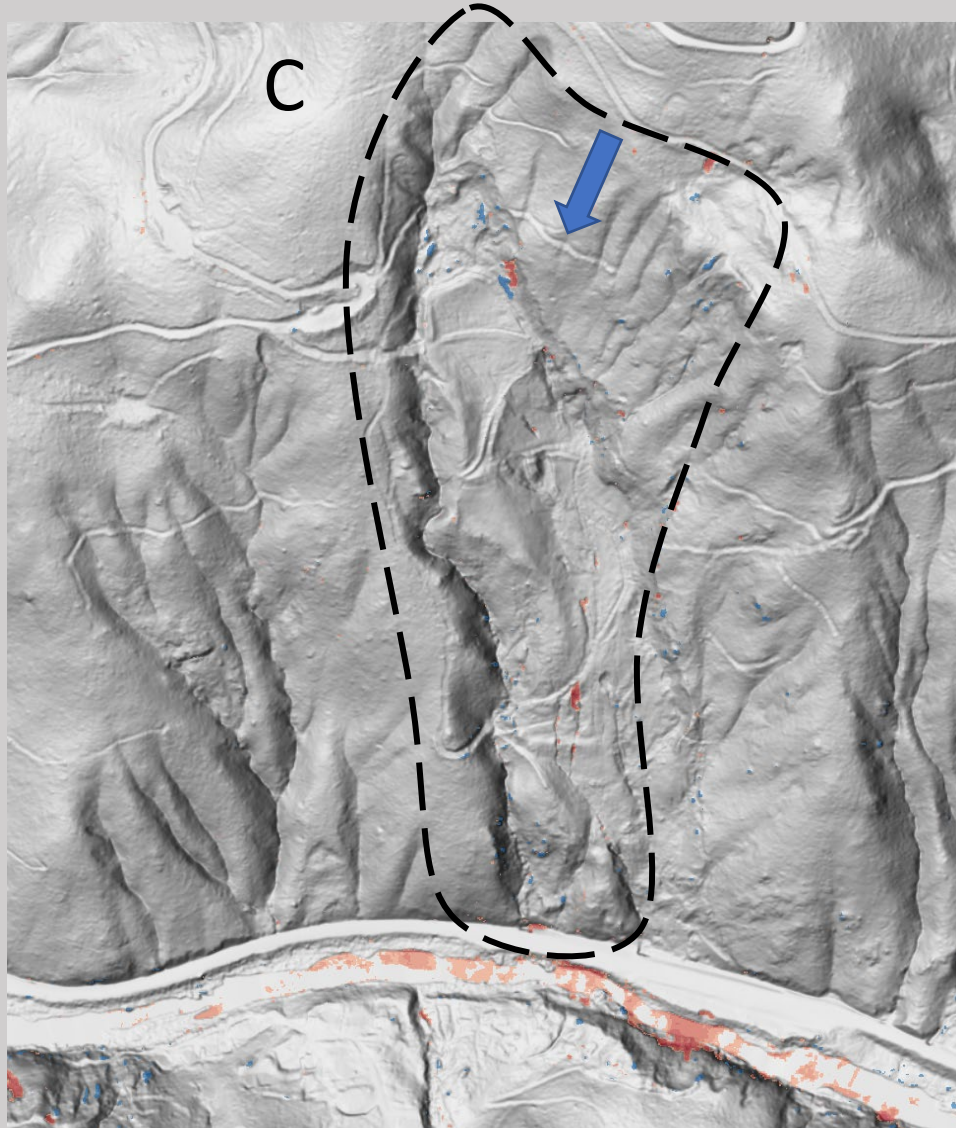
1992 Cleveland Fire

Mill Creek Landslide 1997 & 1983 "Pony Express Lake" Landslide

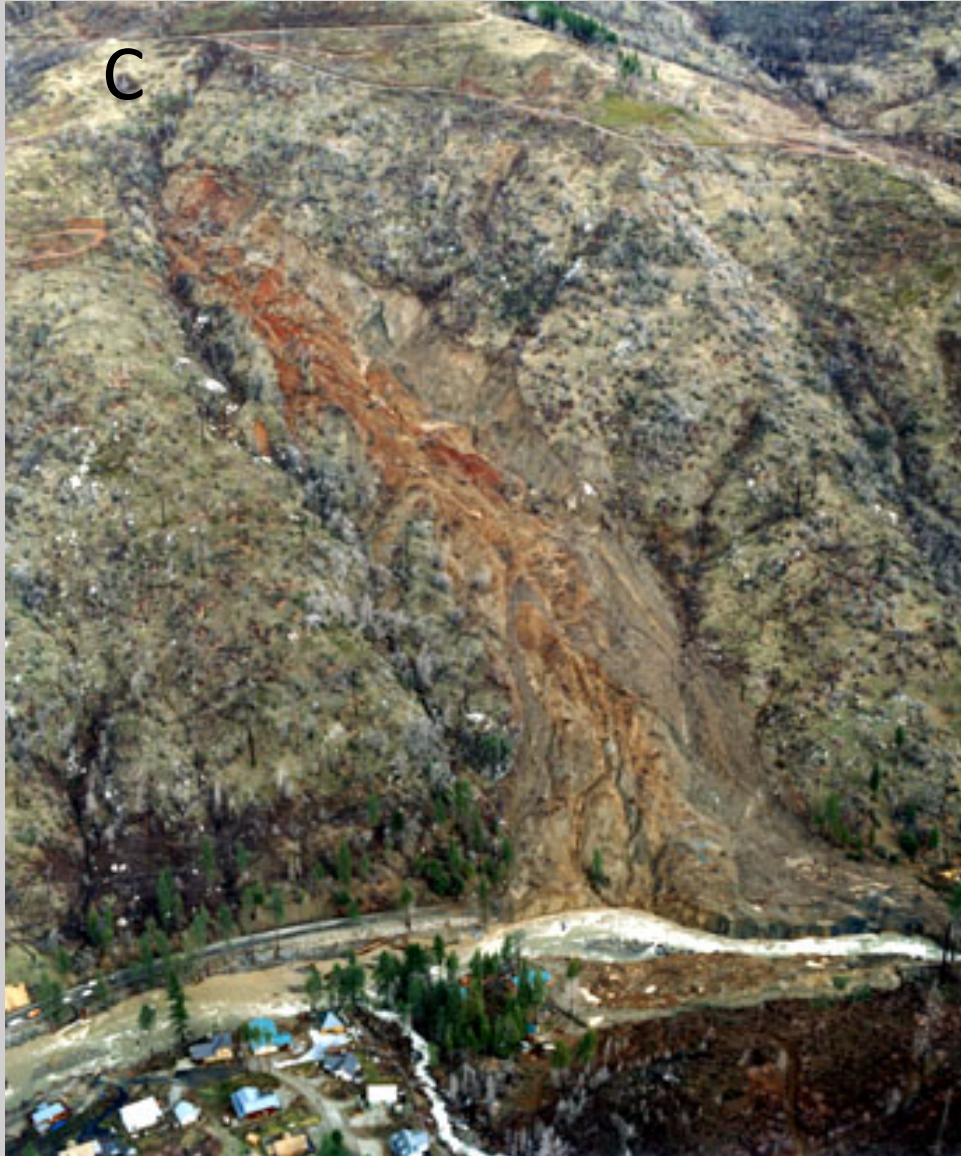
1992 Cleveland Fire

Mill Creek Landslide 1997 & 1983 “Pony Express Lake” Landslide
