Final Report to the California State Board of Forestry and Fire Protection Monitoring Effectiveness Committee

EMC -2018-003 Alternative Meadow Restoration

Principal Investigator: Christopher Surfleet, Professor
Natural Resources Management and Environmental Sciences Department
California Polytechnic State University
San Luis Obispo, California 93407

July 31, 2023

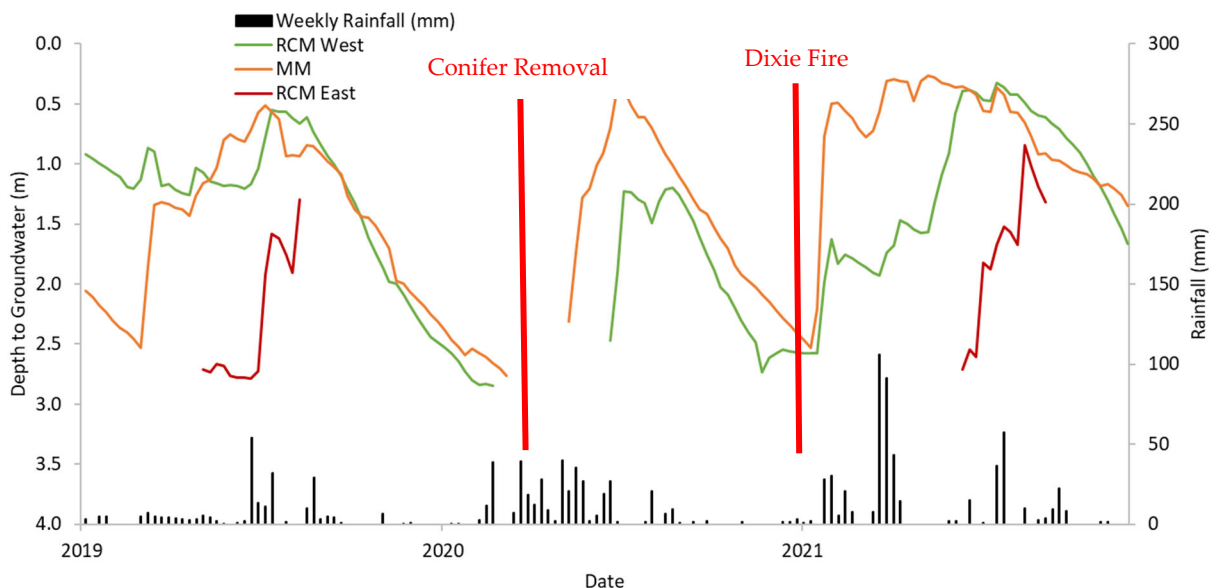
Figure 12. Weekly average depth to groundwater and weekly total precipitation for Marian and Rock Creek Meadows for the 2014-2022 Water Years. The time of the *Pinus contorta* removal and Dixie Fire are shown as well as weekly precipitation.

The average depth to groundwater and weekly precipitation for the western and eastern portions of RCM compared to MM are shown for 2019-2022 water years (Figure 12). The average depth to groundwater pre- and post-conifer removal was determined to be, on average, 0.56 m deeper at Rock Creek following the removal of encroached conifers (2021-2022 water years). The regression analysis of Rock Creek western portion compared to Marian Meadow showed a statistically significant decrease in groundwater the 1st year (2021 WY) following the restoration but no difference the 2nd year (2022 WY following the Dixie Fire) (Table 7; Figure 13). The eastern portion of Rock Creek Meadow only had measurable groundwater for a short portion in the pre-restoration year (2020 WY) and the 2nd year post-restoration (2022). The 2021 water year was a drought year, there were instrument malfunctions for portions of 2020 and 2022 water years that were partially responsible for the incomplete groundwater data set for the eastern portion of RCM. Therefore, no statistical evaluation was performed on the RCM East measurements. Only the western portion of RCM was used for statistical evaluation.

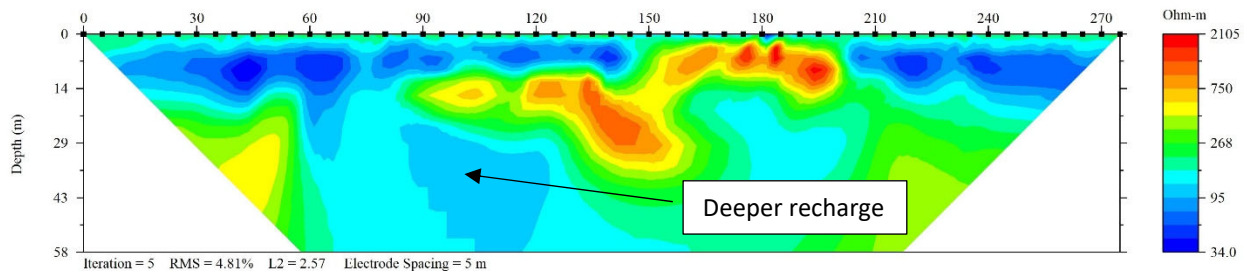
Figure 14. Rock Creek Deep Electrical Resistivity Profile. This profile trends from the road bisecting Rock Creek Meadow toward instrument and vegetation transect site 1 (Figure 3). The right side of the image (horizontal position of 275 meters) is located at $(40.3307^\circ, -121.0873^\circ)$, with a heading of 40° . The electrode spacing is 5 meters. Data was collected with a dipole-dipole-gradient pattern.

The low resistivity values contoured in blue in a roughly horizontal band near the top of Figure 1 indicate a sediment/soil that contains discrete regions with laterally varying amounts of clay minerals. Below this are two light blue contoured regions (~ 100 Ohm-m) that suggest water from rains and snowmelt is recharging to the deep subsurface through preferential pathways. The recharge rate depends on the hydraulic conductivity of the subsurface and is likely to significantly vary in three dimensions. It is important to note that Figure 14 is a two-dimensional slice through a three-dimensional structure with significant variation of material type. Regions with very shallow igneous rock that is not fractured (or, without a connected fracture network) may allow water, and thus soil moisture, to perch rather than recharge, which may have an effect on meadow vegetation restoration as well as represent an unaccounted-for aspect of the groundwater budget.

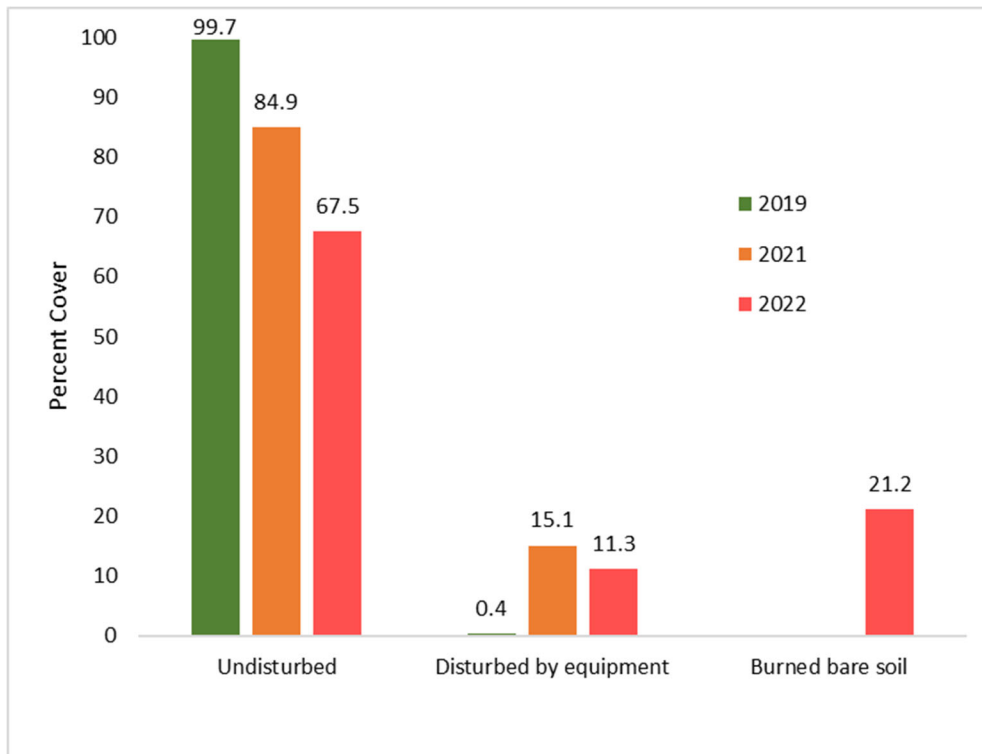
Figure 27. Percent of undisturbed and disturbed soil cover pre-treatment (2019), post-treatment (2021), and 2 years post-treatment after the Dixie Fire (2022) in the Class I WLPZ for Rock Creek Meadow.

The soil cover in the WLPZ was found to be slightly disturbed, 15.3% of soil cover disturbed, by the logging equipment during removal of the encroached *Pinus contorta* (Figure 27). The amount of disturbed soil cover increased to 32.5% the 2nd year following treatment primarily due to burnt soil cover, 21.2%, from the Dixie Fire (see Figures 27, 5, and 6). The percentage of equipment disturbance was reduced by 4% in 2022 compared to 2021 from vegetation recovery of the disturbed soil cover.
