To quantify changes to meadow conditions once conifers have been cleared from the meadow and identify if there is an environmental benefit.

Does the removal of conifers on historical meadows, create a hydrologic response to restore montane meadow habitat?

The southern Cascades/northern Sierra Nevada mountain range, near Chester, CA.

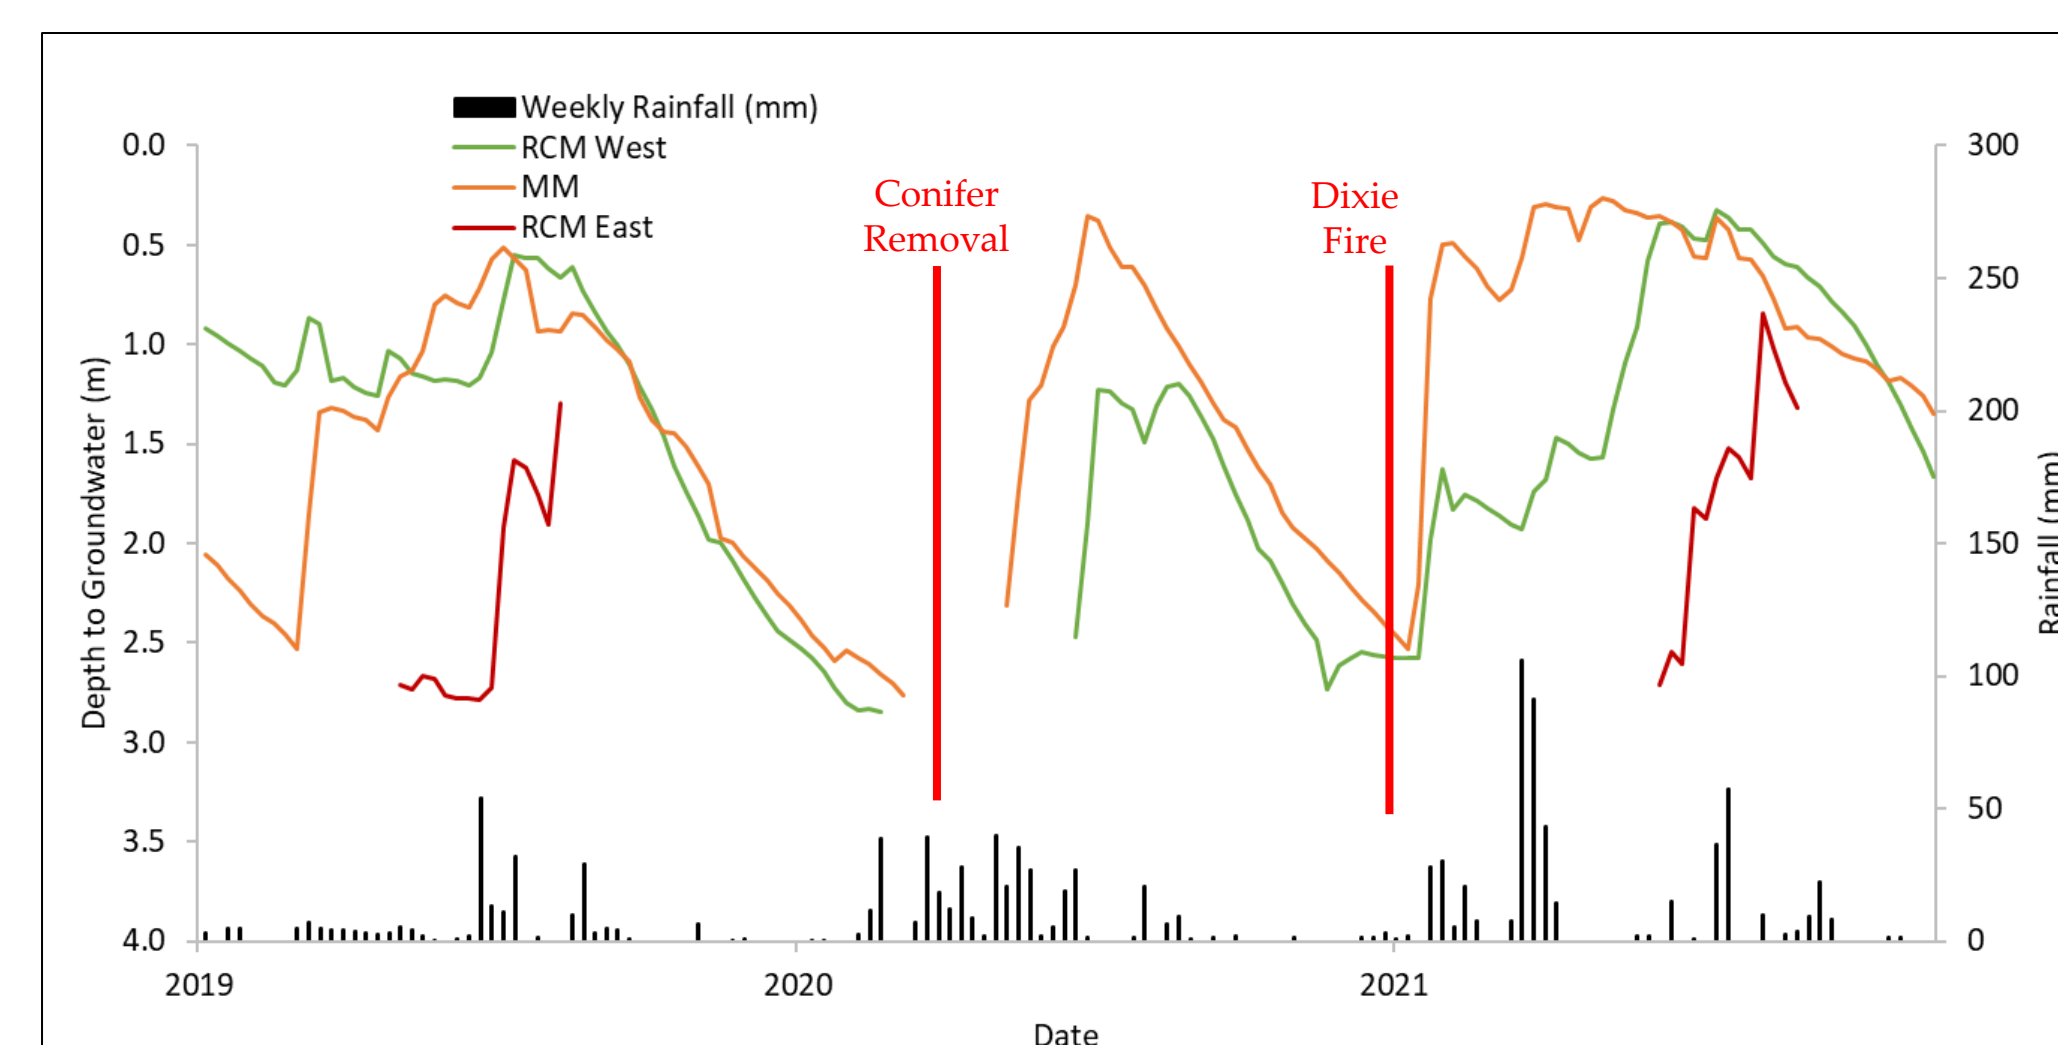
Figure 3. Weekly average depth to groundwater and weekly total precipitation for Rock Creek (RCM) and Marian Meadows (MM) between the 2020-2022 Water Years (WY). The RCM groundwater data is differentiated between the western and eastern portions of the meadow. The time of *Pinus contorta* removal and the Dixie Fire is denoted in the time series.

- Improvement in Rock Creek Meadow groundwater (Figure 3) is mixed following the removal of *Pinus contorta*, likely due to severe drought in the 2020 and 2021 water years.
- The 2022 water year shows increased groundwater following the 2021 Dixie Fire (Figure 3). This is further supported by the Year 2 post-restoration 0.34 p-value (Table 1) which indicates similar groundwater levels between Rock Creek and Marian Meadows despite a likely increase in runoff and groundwater recharge in Marian Meadow due to high soil burn severity (Table 4).
- Rock Creek Meadow soil moisture appeared to increase (Figure 6) within the first year following the removal of *Pinus contorta*. This is further illustrated by Figure 7.

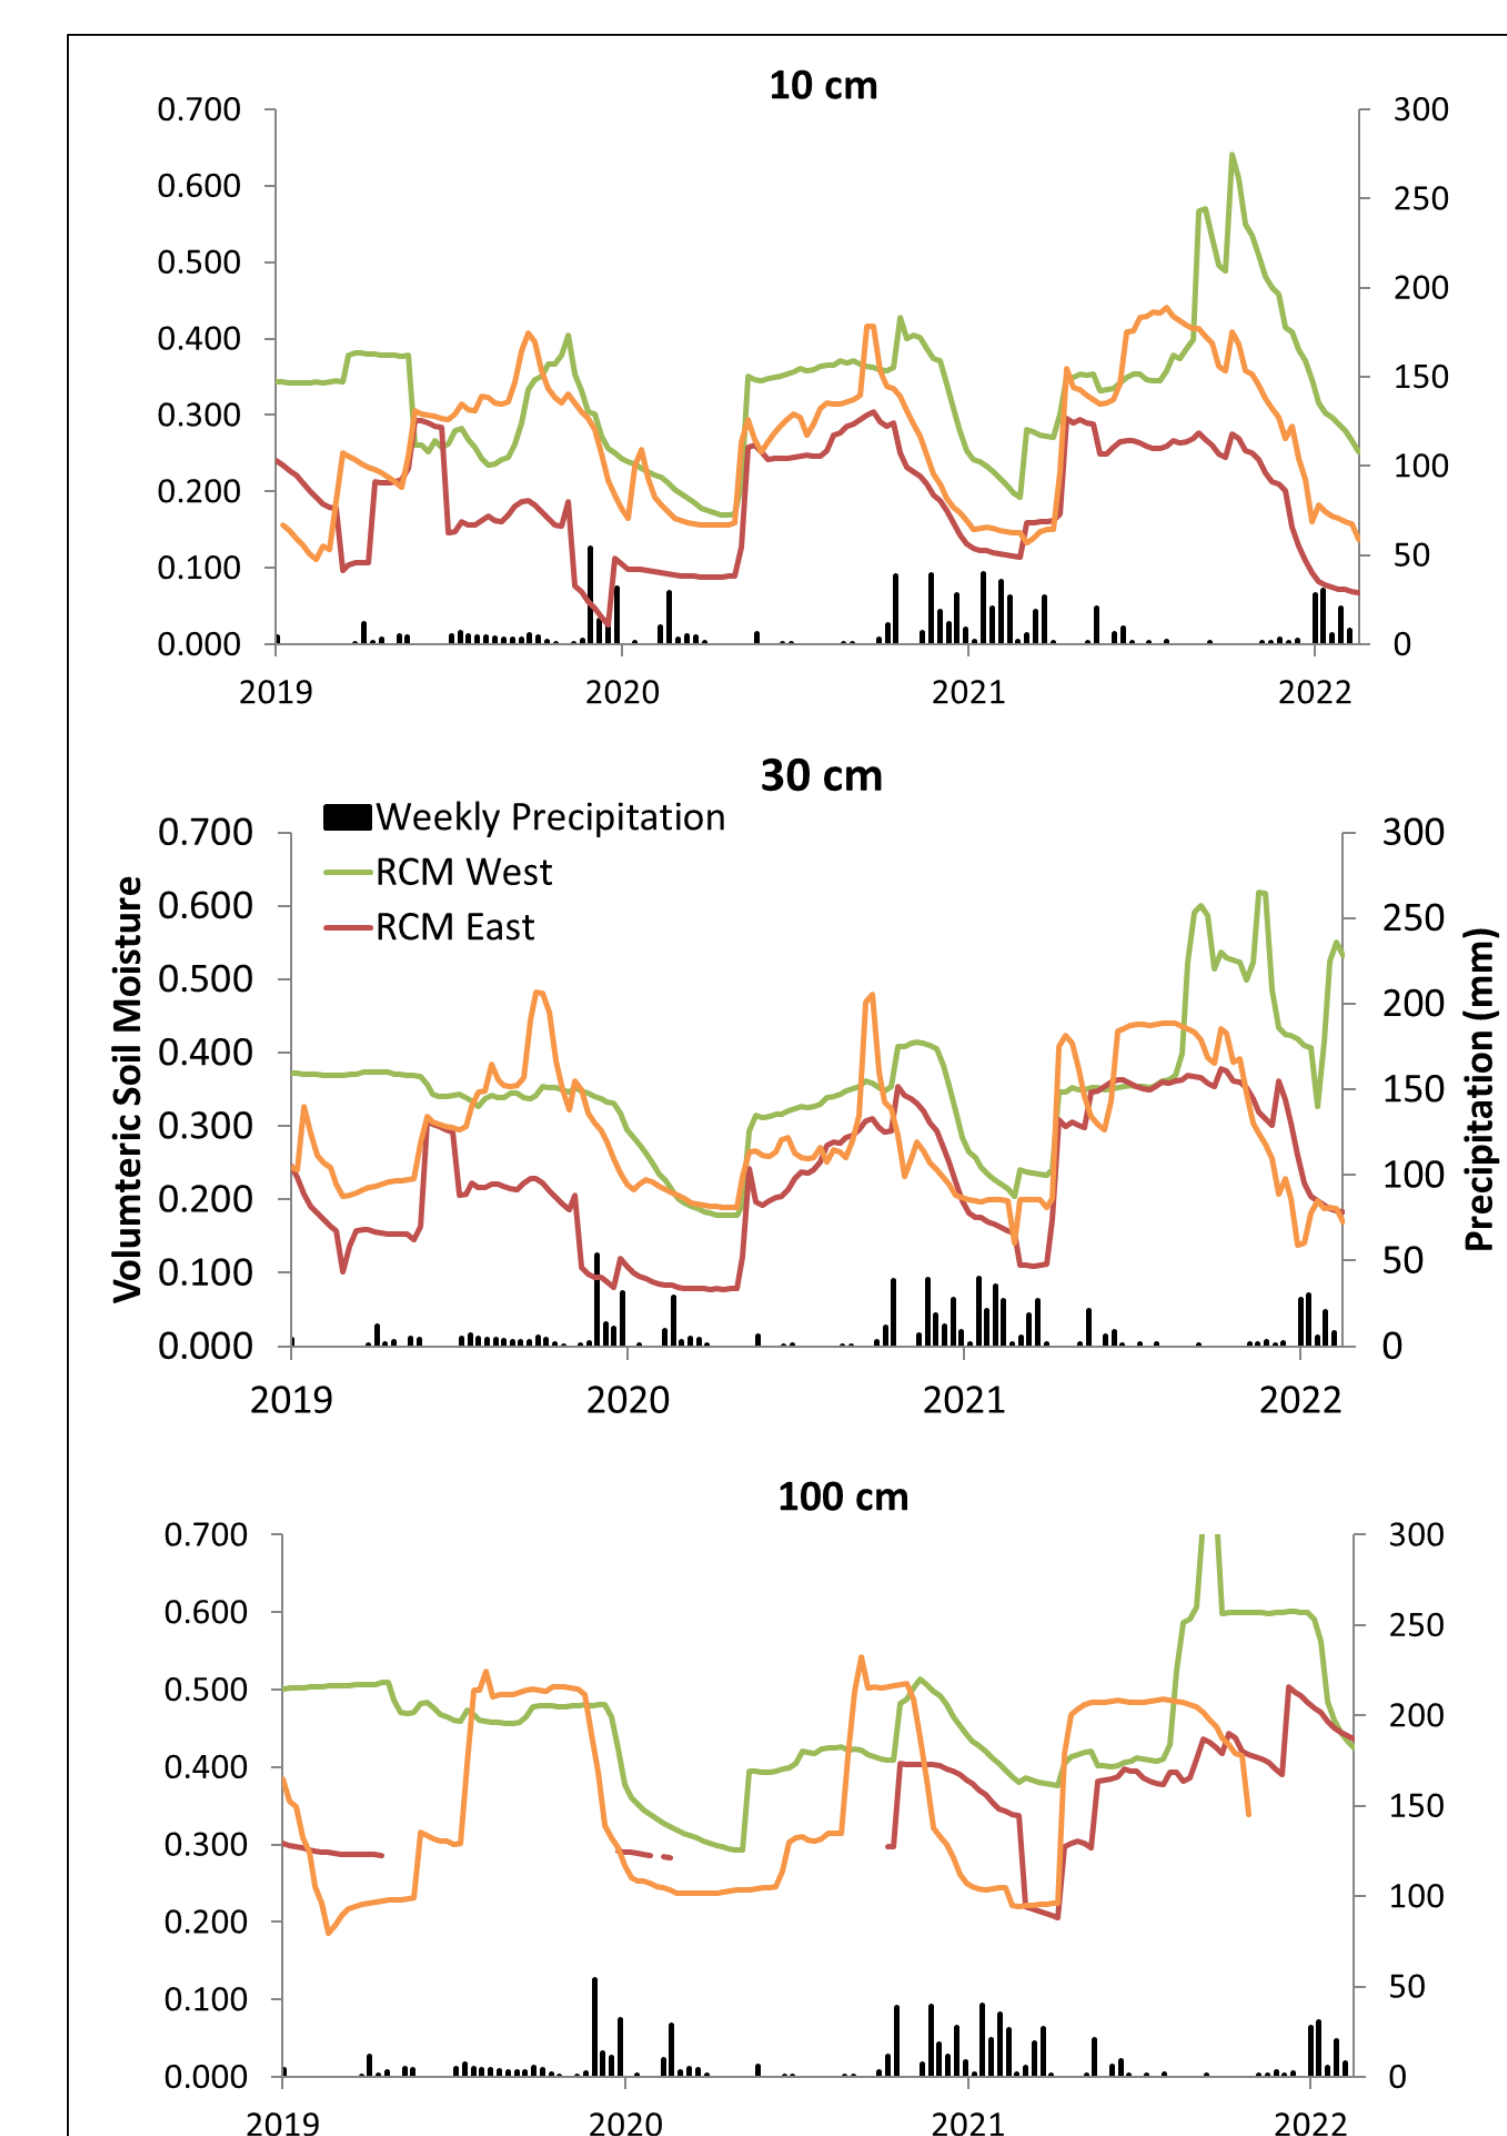
Figure 6. Weekly average volumetric soil moisture percentage and weekly total precipitation for Rock Creek (RCM) and Marian Meadows (MM) between the 2020-2022 WY at depths of 10, 30 and 100 cm. The RCM soil moisture data is differentiated between the western and eastern portions of the meadow.

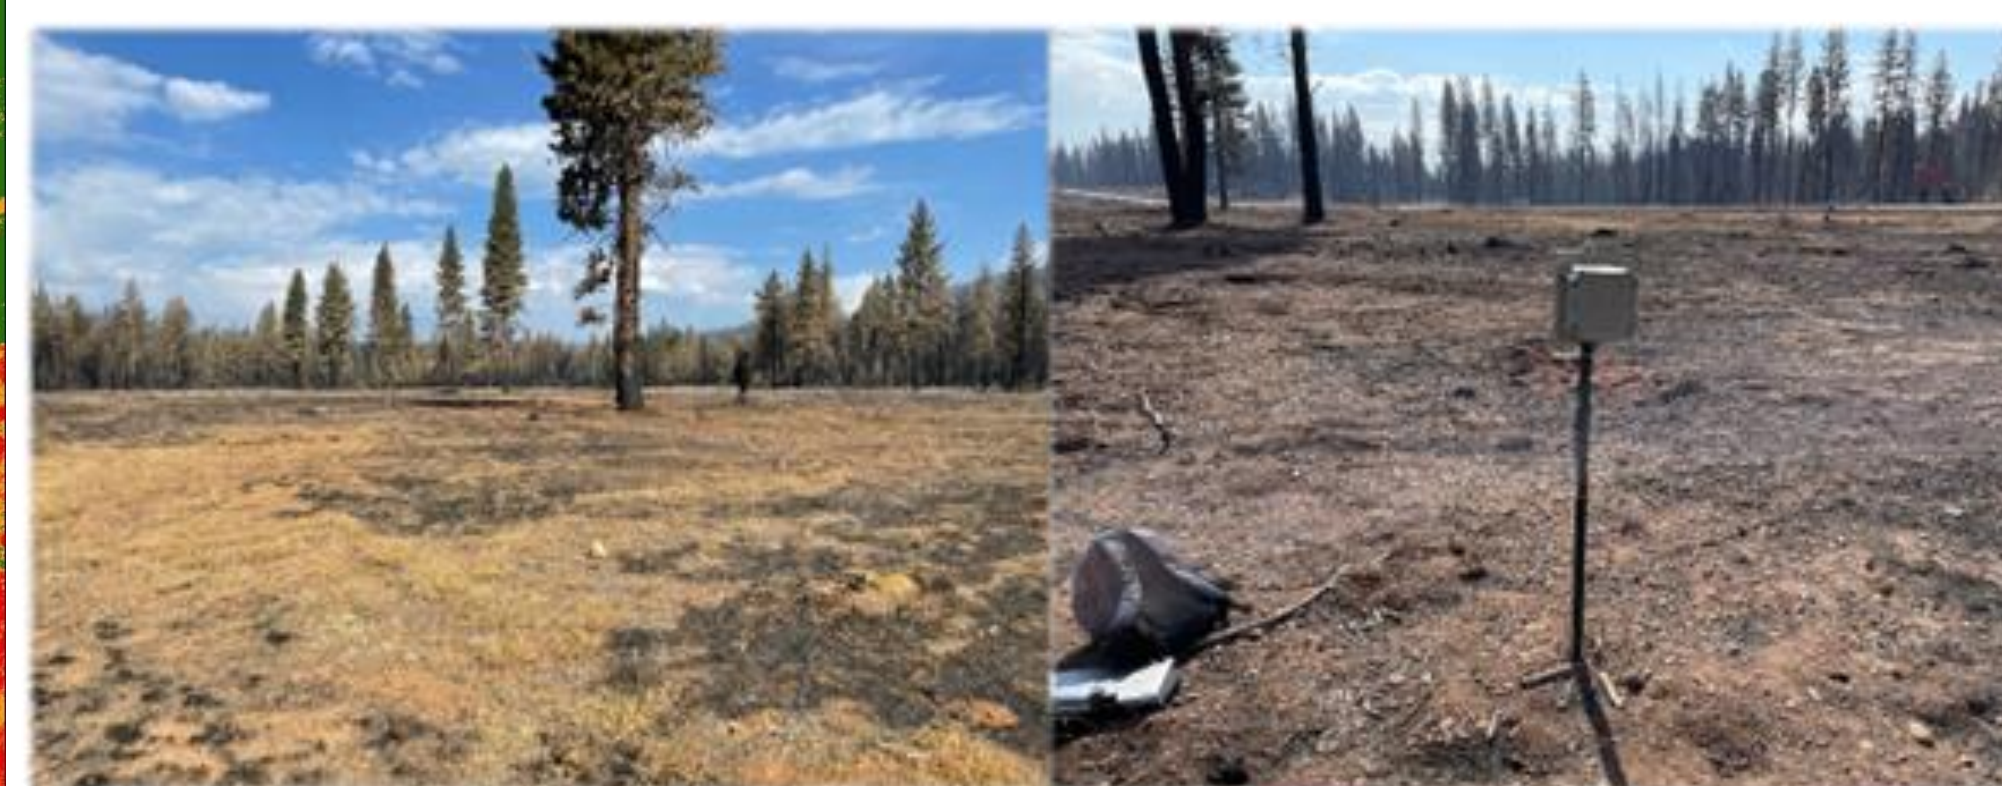
Figure 9. The left image is of Rock Creek Meadow with patches of burnt meadow vegetation. The right image is of Marian Meadow with moderate to high soil burn severity around one of the soil moisture data loggers. Both photos were taken by Dr. Surfleet one month after the Dixie Fire in September 2021.
