Railroad Gulch best management practices evaluation: A paired watershed study

HUMBOLDT STATE UNIVERSITY

Supported by a grant from the California Board of Forestry
Monitoring Study Group

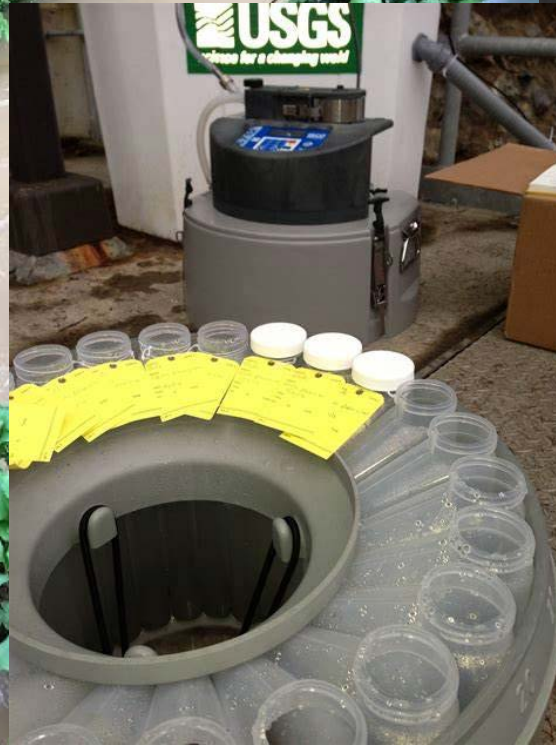
Sediment Yield at the Mouth

- ◇ Storm and Annual Sediment Loads
- ◇ Continuous Turbidity Monitoring
- ◇ Pump Sampler for Suspended Sediment Concentration
- ◇ Continuous Stage Monitoring
- ◇ Discharge Rating Curve from Field Measurements

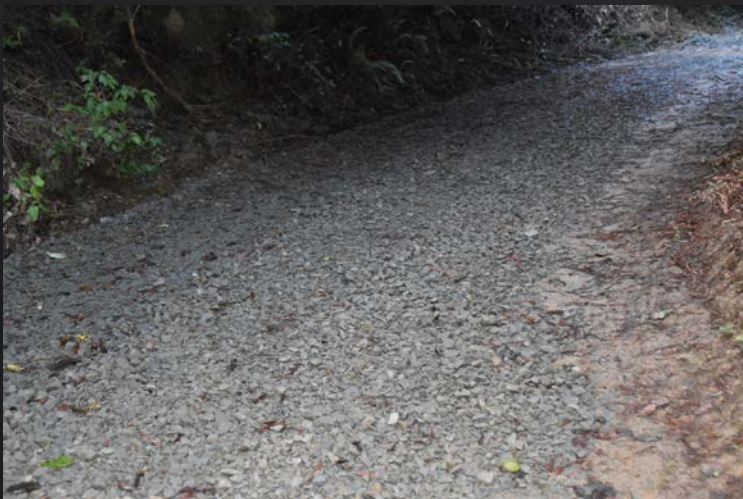
Issue:
Section of Haul
Road Traverses
Control Watershed

Impact minimized by
rocking and erosion control
wattles on water bars

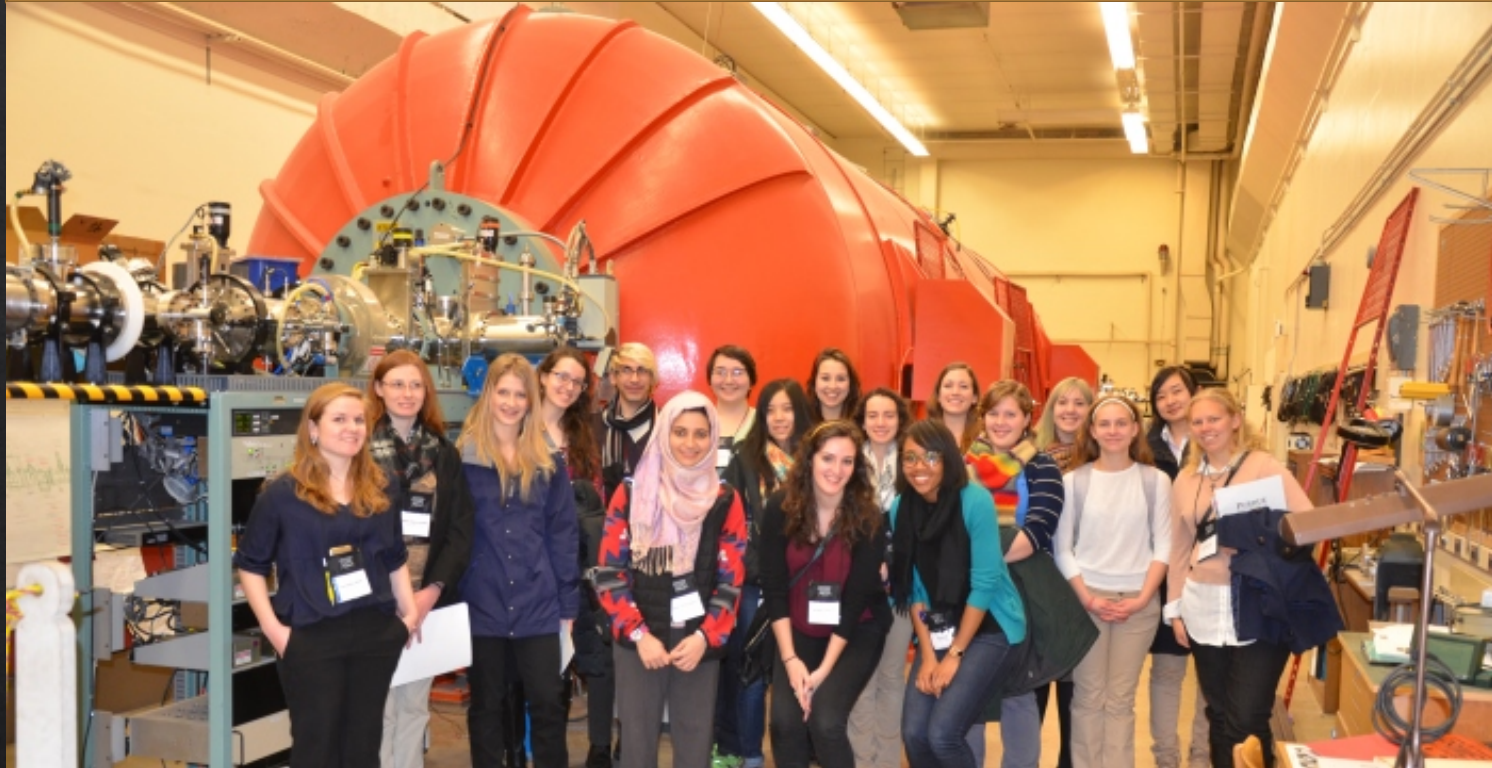
Long Term Erosion Rates

Field samples analyzed by accelerator mass spectrometry for Be-10 at Purdue. Higher Be-10 correlated with lower catchment erosion rates.

- ◆ Be-10 derived erosion rates, indicative of erosion rates over millennial time scales, are similar to present day rates
- ◆ Average rainfall years had erosion rates that were very similar to the long term average erosion rate
- ◆ Wetter years and landsliding elevated erosion rates above long term rates, while drier years were much lower

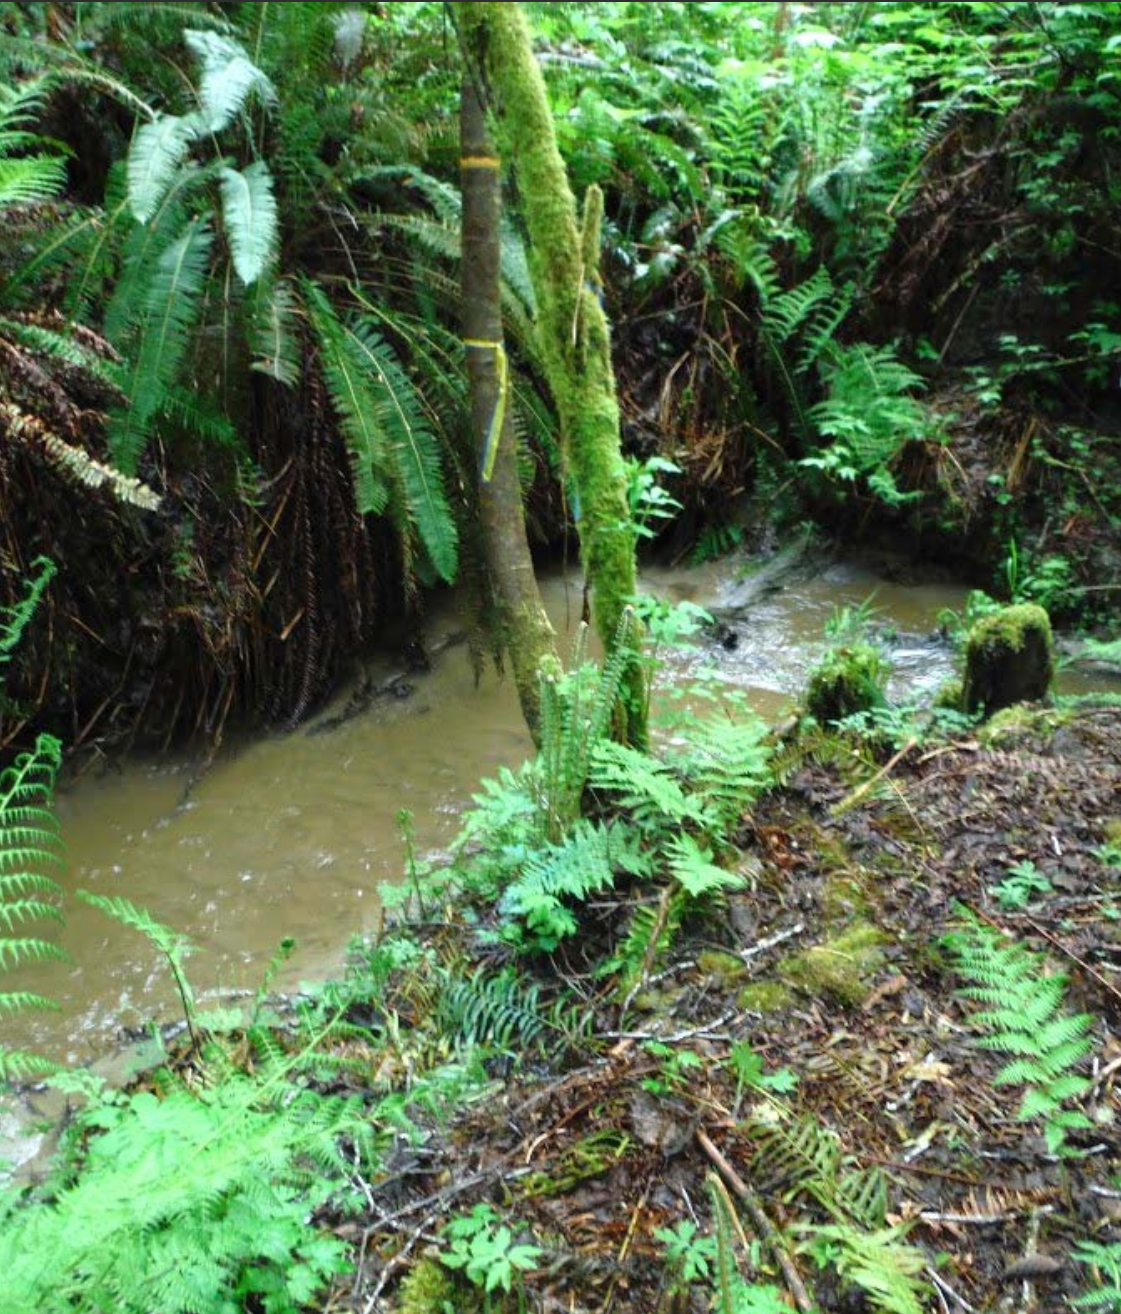
Peak Flows

- Continuous discharge stations.
- Rainfall data.
- Analysis of peak flows, runoff coefficient (Q/P) and rainfall intensities.

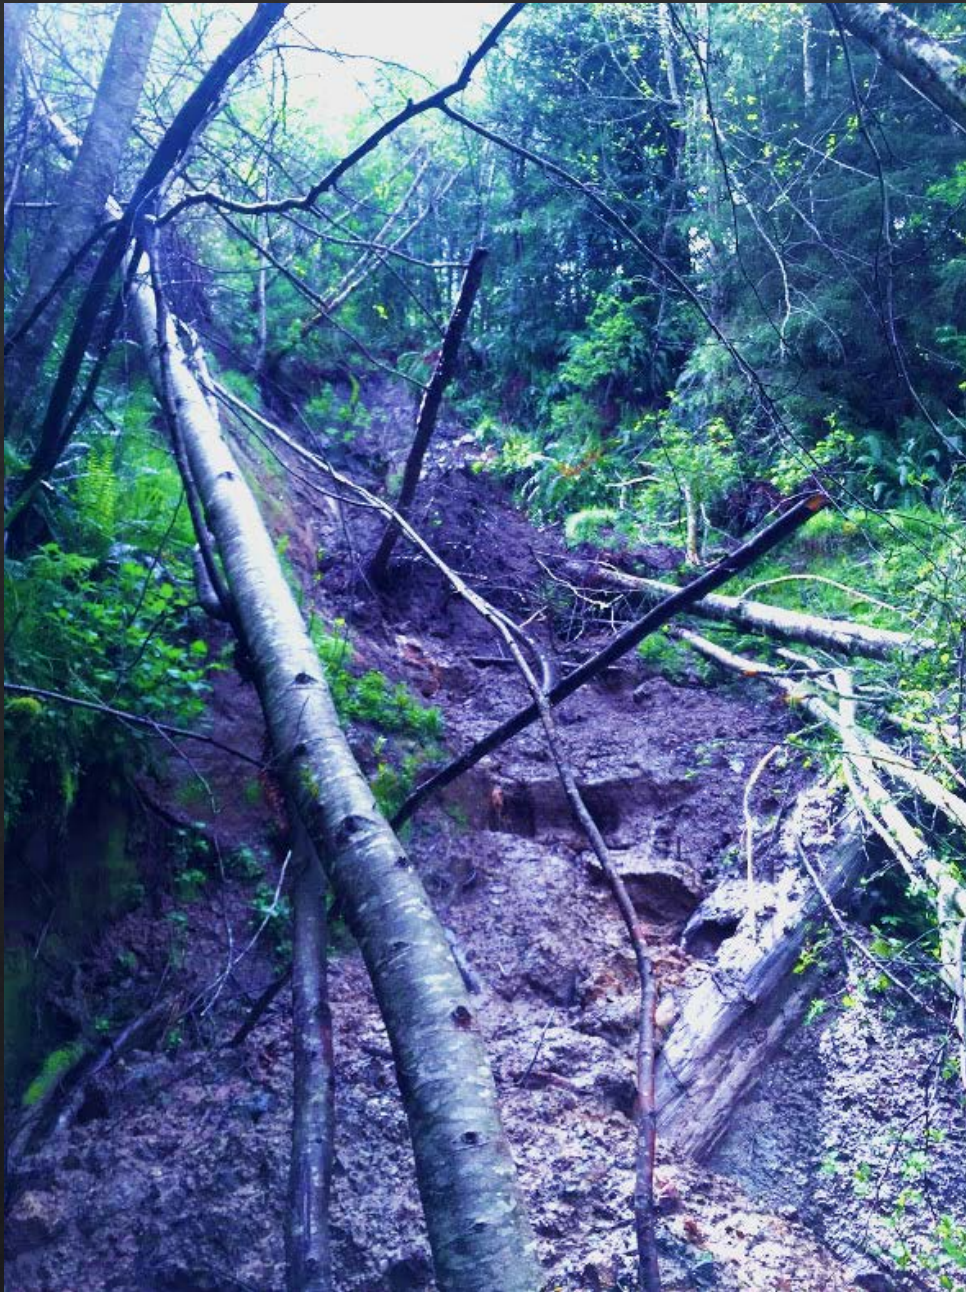
Landslides

Annual aerial
photography
and field
inspection

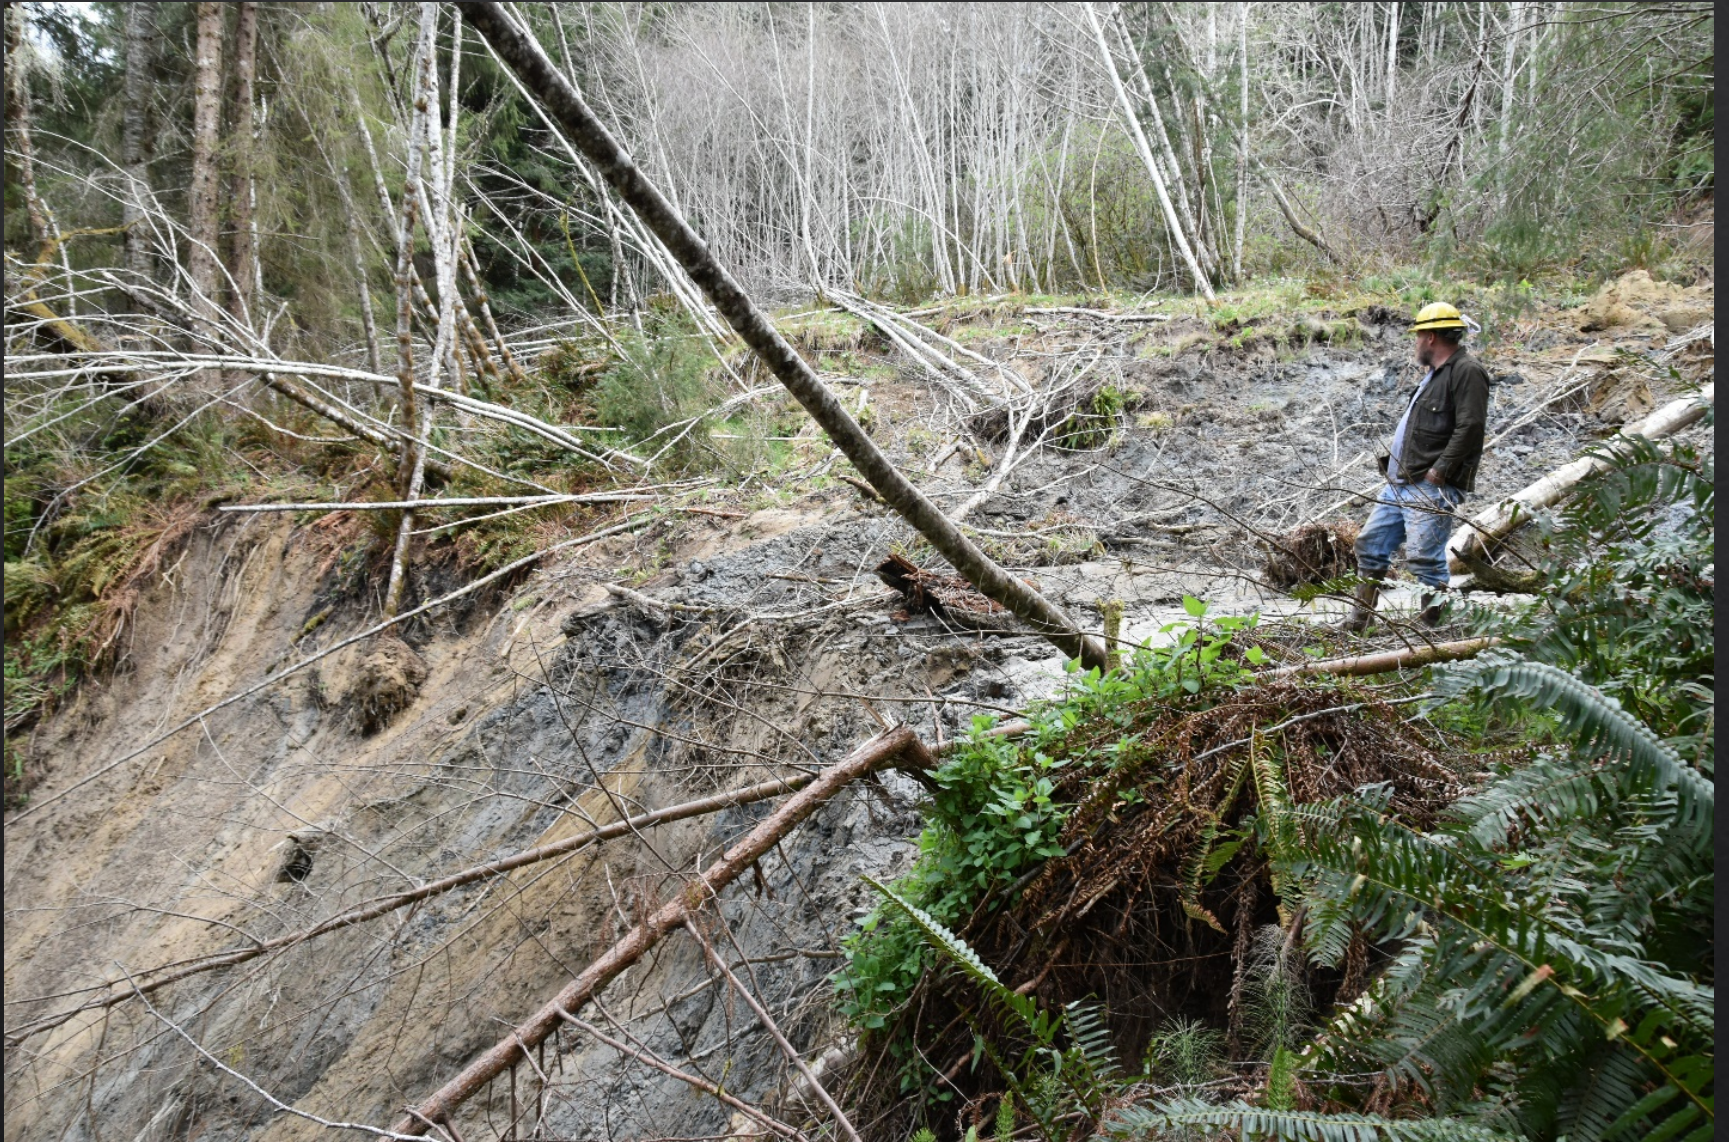
Earth flow on West Branch, Railroad Gulch.

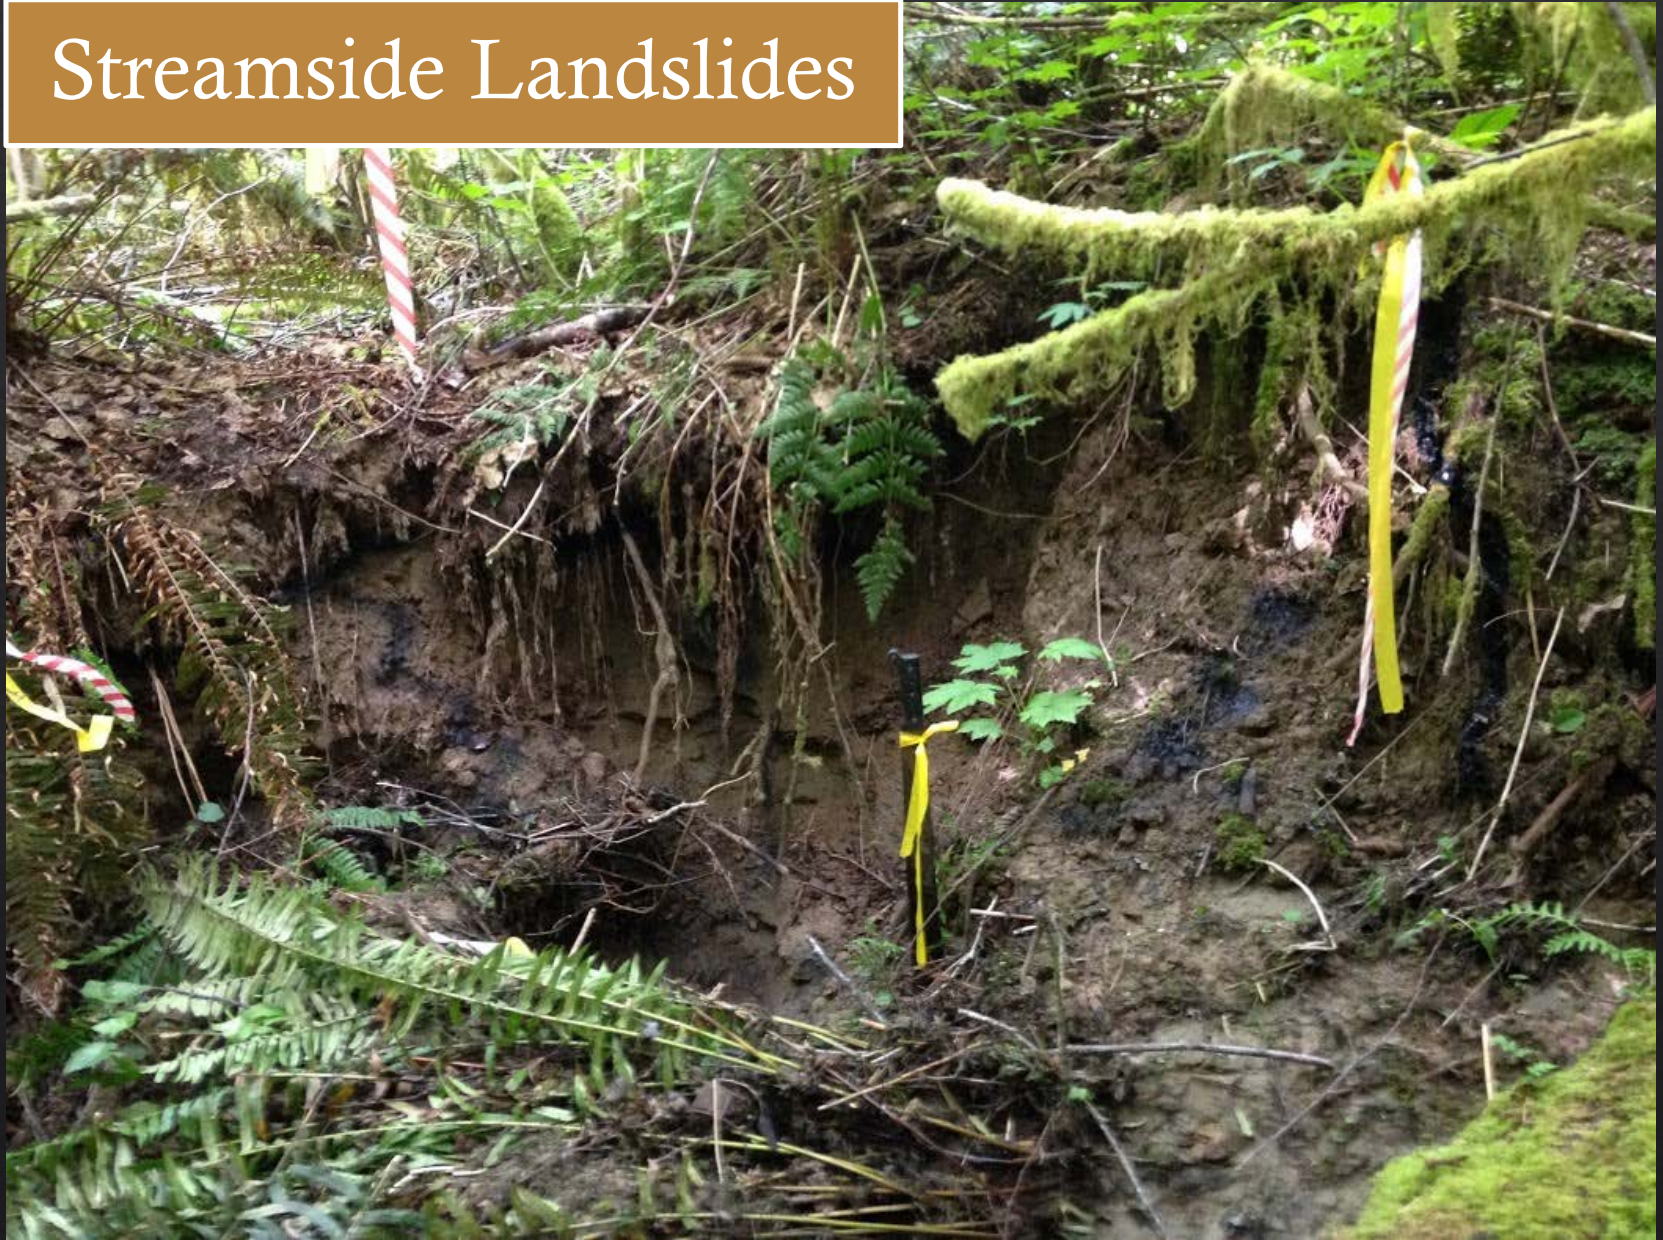
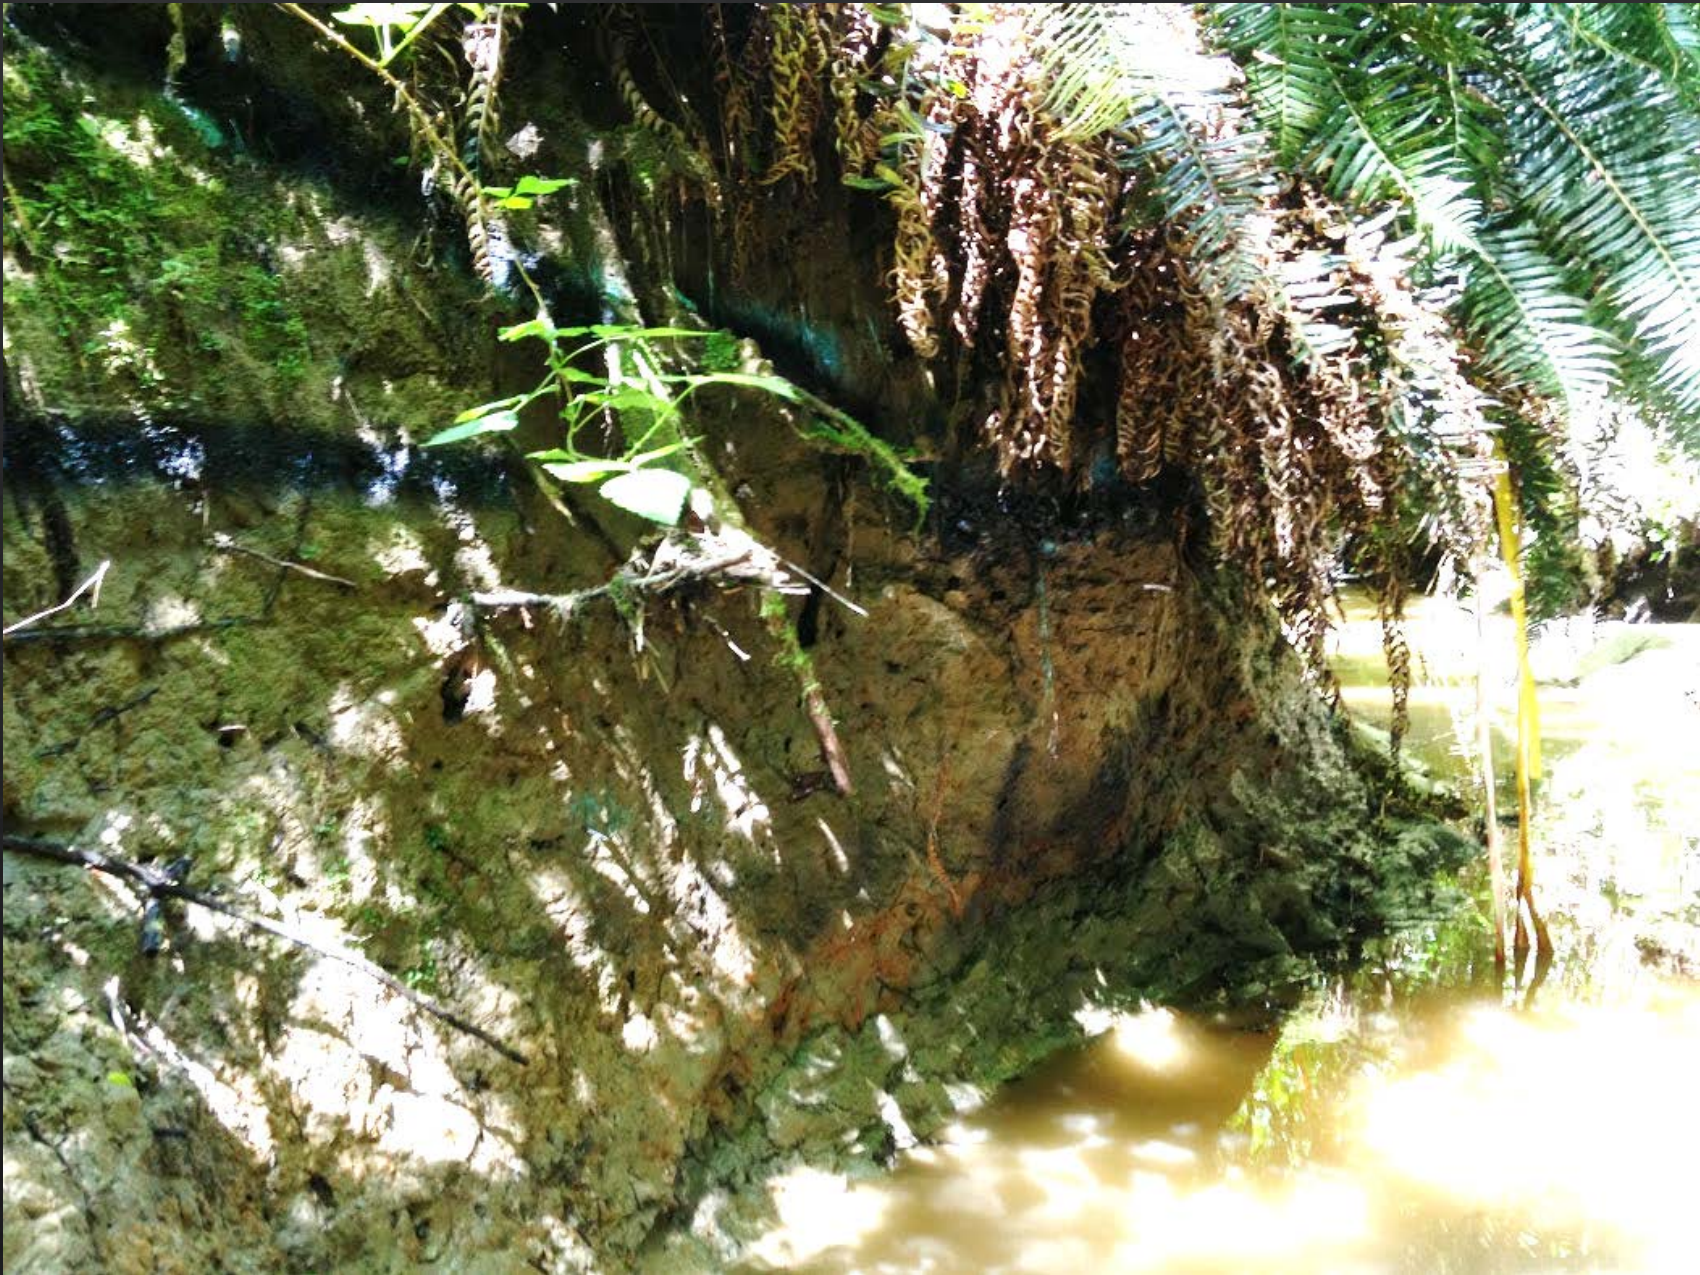
Streamside Landslides

Methods: Annual
field inspection of
lower 2600 feet.

Painting Banks,
Volume of void

- ◇ Landslides did not occur in or adjacent to harvest areas
- ◇ Small streamside landsliding increased with rainier years and higher peak flows
 - ◇ While streamside landsliding increased in the harvest unit in 2018 and 2019, this was only observed at single locations, with very little erosion overall
- ◇ Tributaries did not appear to affect turbidity in the main stem
 - ◇ Exceptions included tributaries draining the WB landslide, a tributary incising into an earth flow, and a tributary intersecting an old spur road

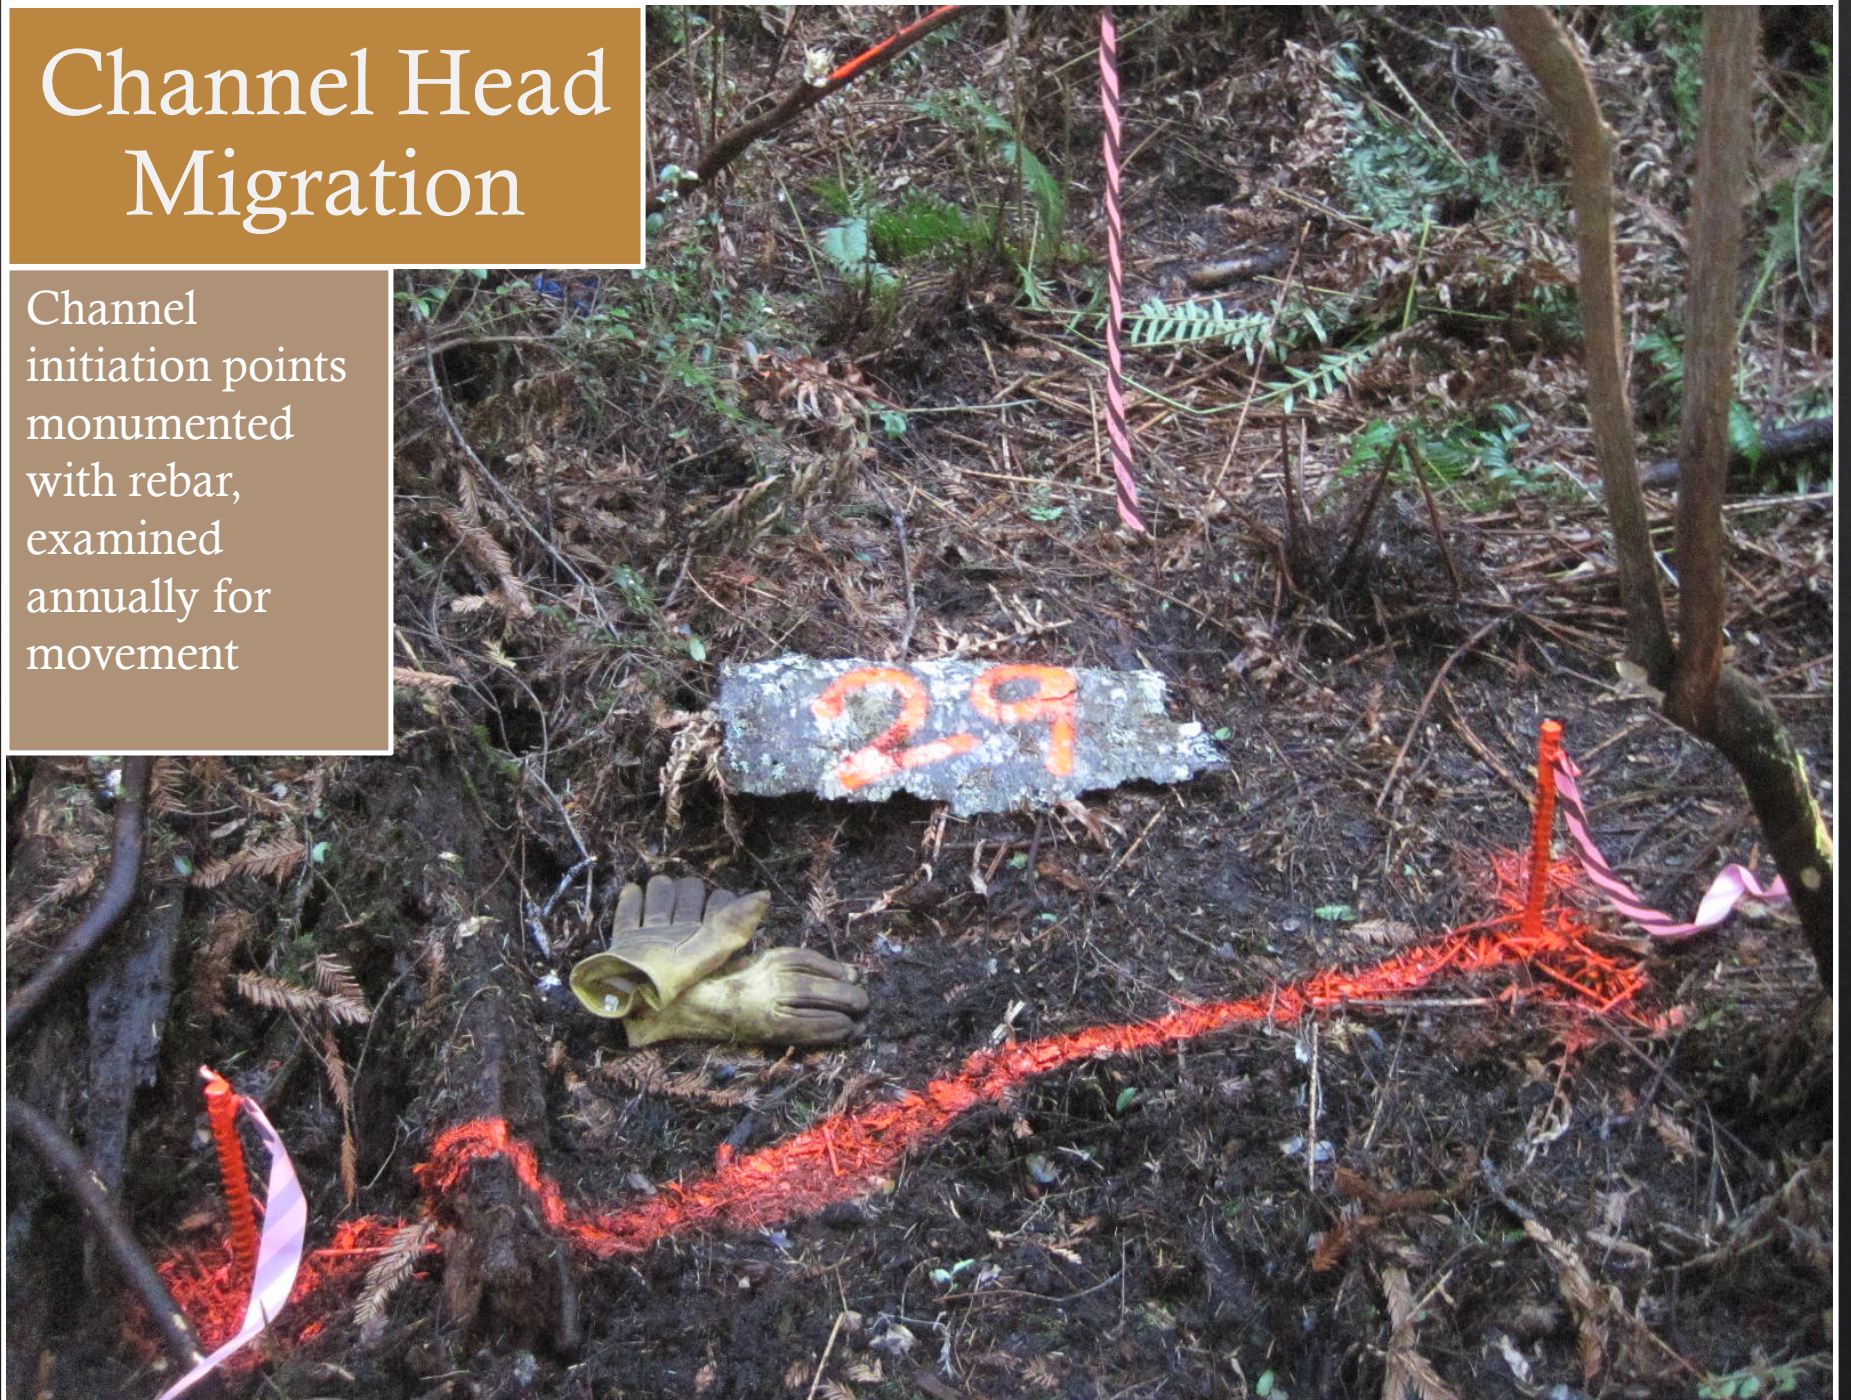
Channel Head Migration

Channel initiation points monumented with rebar, examined annually for movement

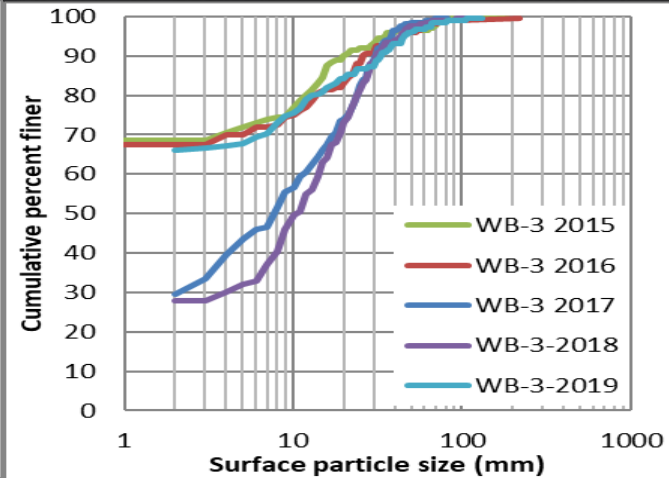
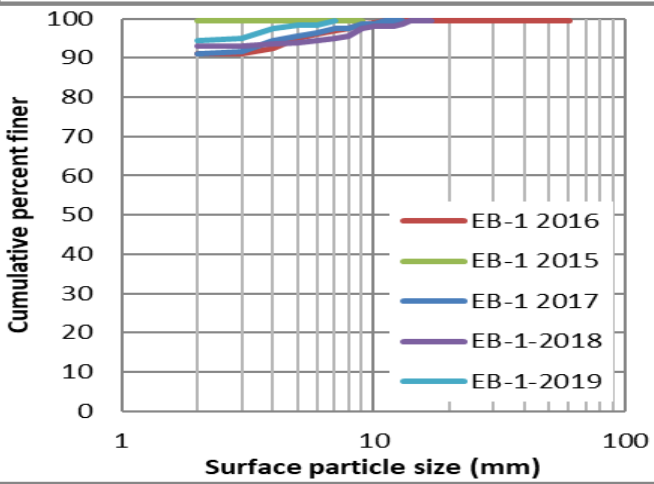
Bed Material

headwater

mouth

- ◇ General trend of bed scour, may reflect long-term adjustment to massive floodplain sedimentation after harvest of old-growth forest in 1900s
- ◇ Scour and coarsening are associated, as are the converse, fill and fining trends
- ◇ Greatest scour in wettest years, some fill in drier years
- ◇ Fill trend evident after WB landslide
- ◇ Changes to stream size and bed material from harvest not evident
- ◇ No changes to headwater channel initiation points observed over study

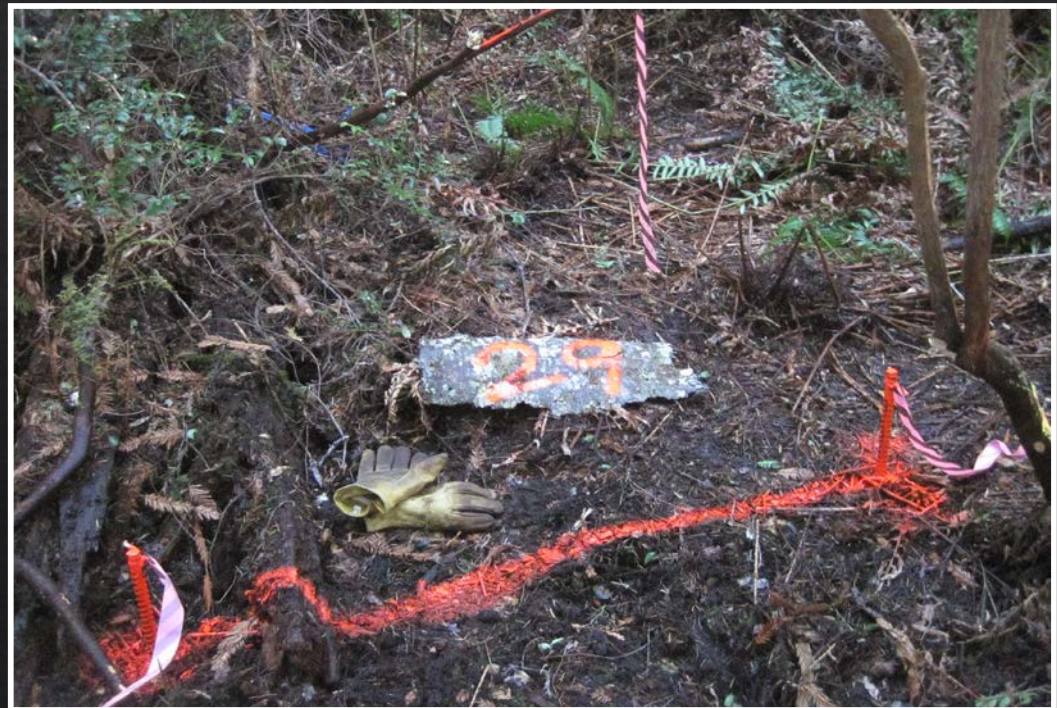
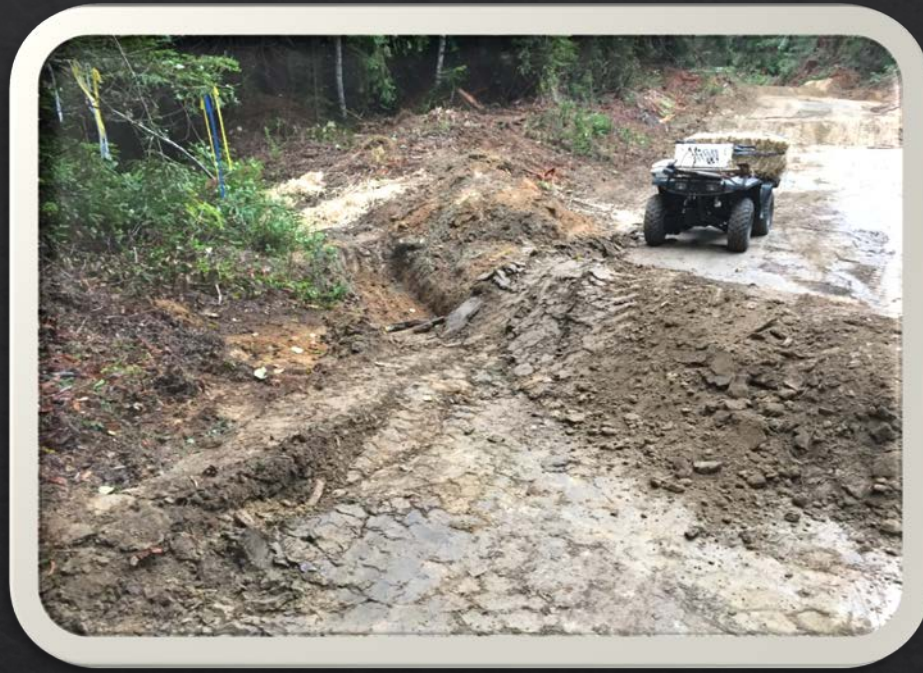
Rate of retreat of channel initiation points at the head of watercourses

- ◆ No changes, channels were stable throughout study period
