Effectiveness of meadow and wet area restoration as an alternative to watercourse and lake protection (WLPZ) rules

Christopher G. Surfleet

Final Presentation to California's Board of Forestry
Effectiveness Monitoring Committee

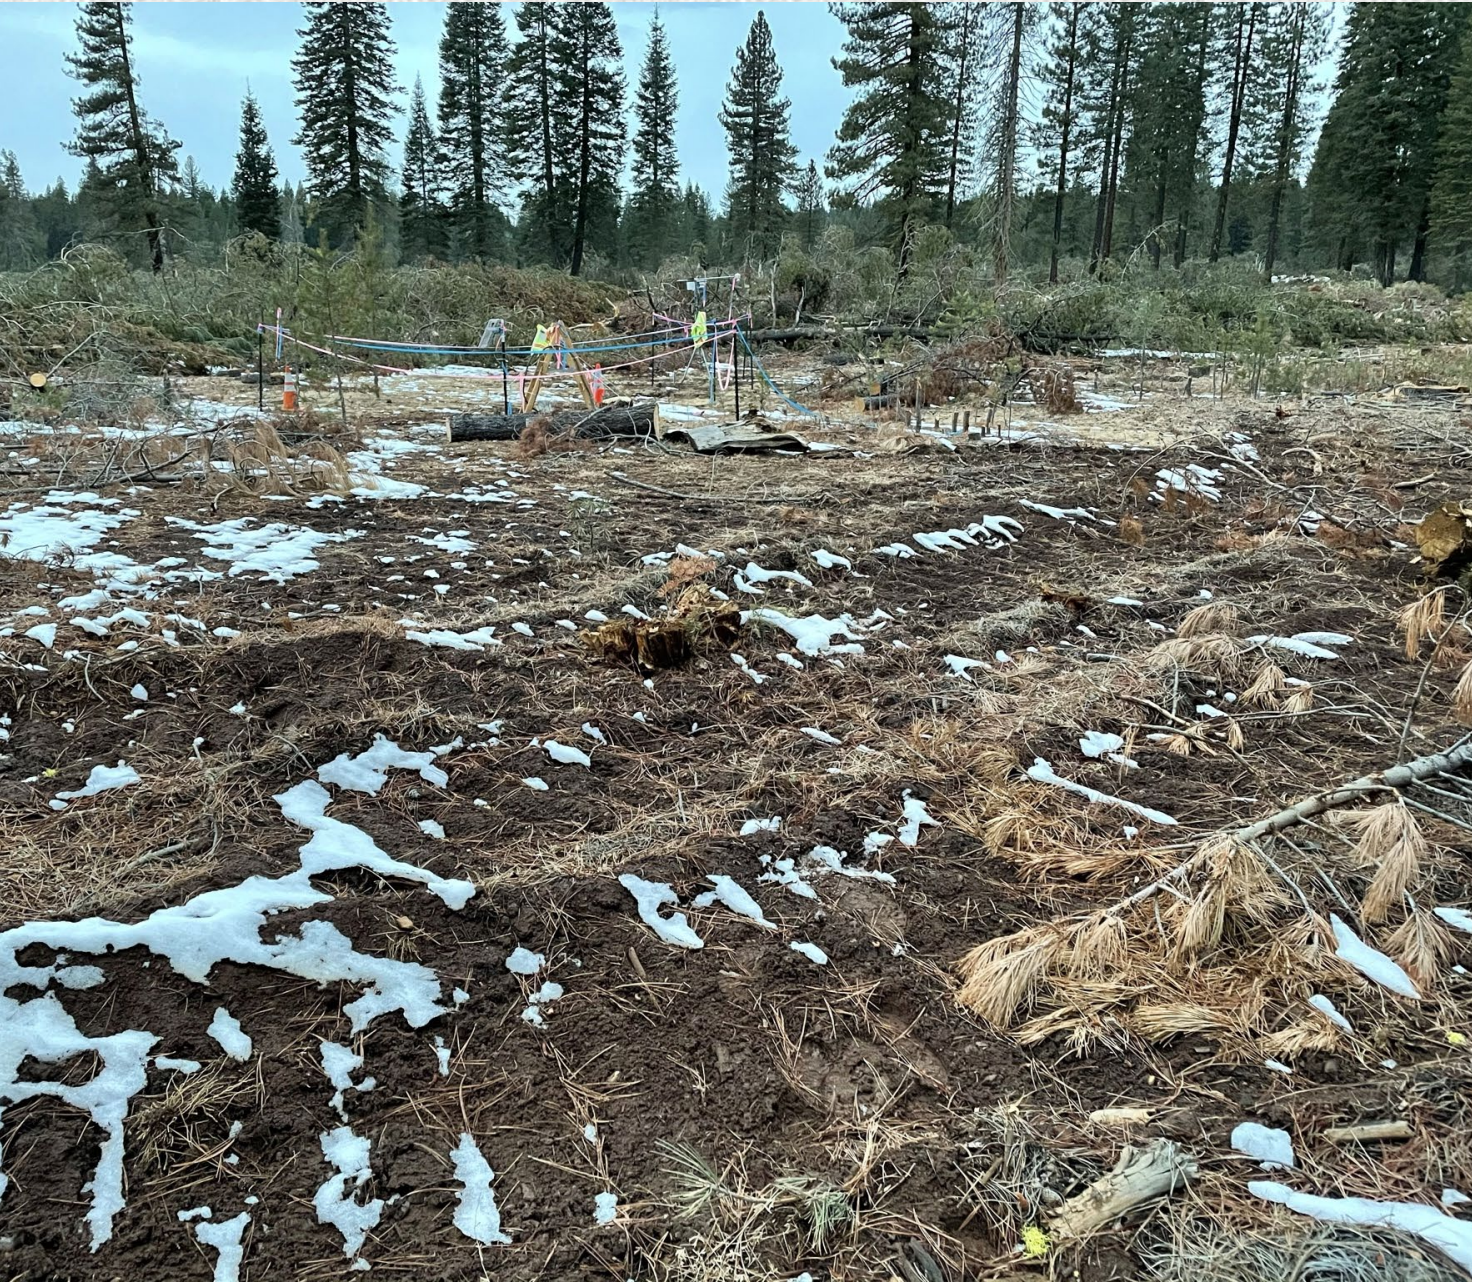
Soil Disturbance and Compaction

4 locations – 500 feet long

Transects at 30, 50 and 75 feet from watercourse.

Randomly selected soil bulk density samples at transects at all 4 locations.

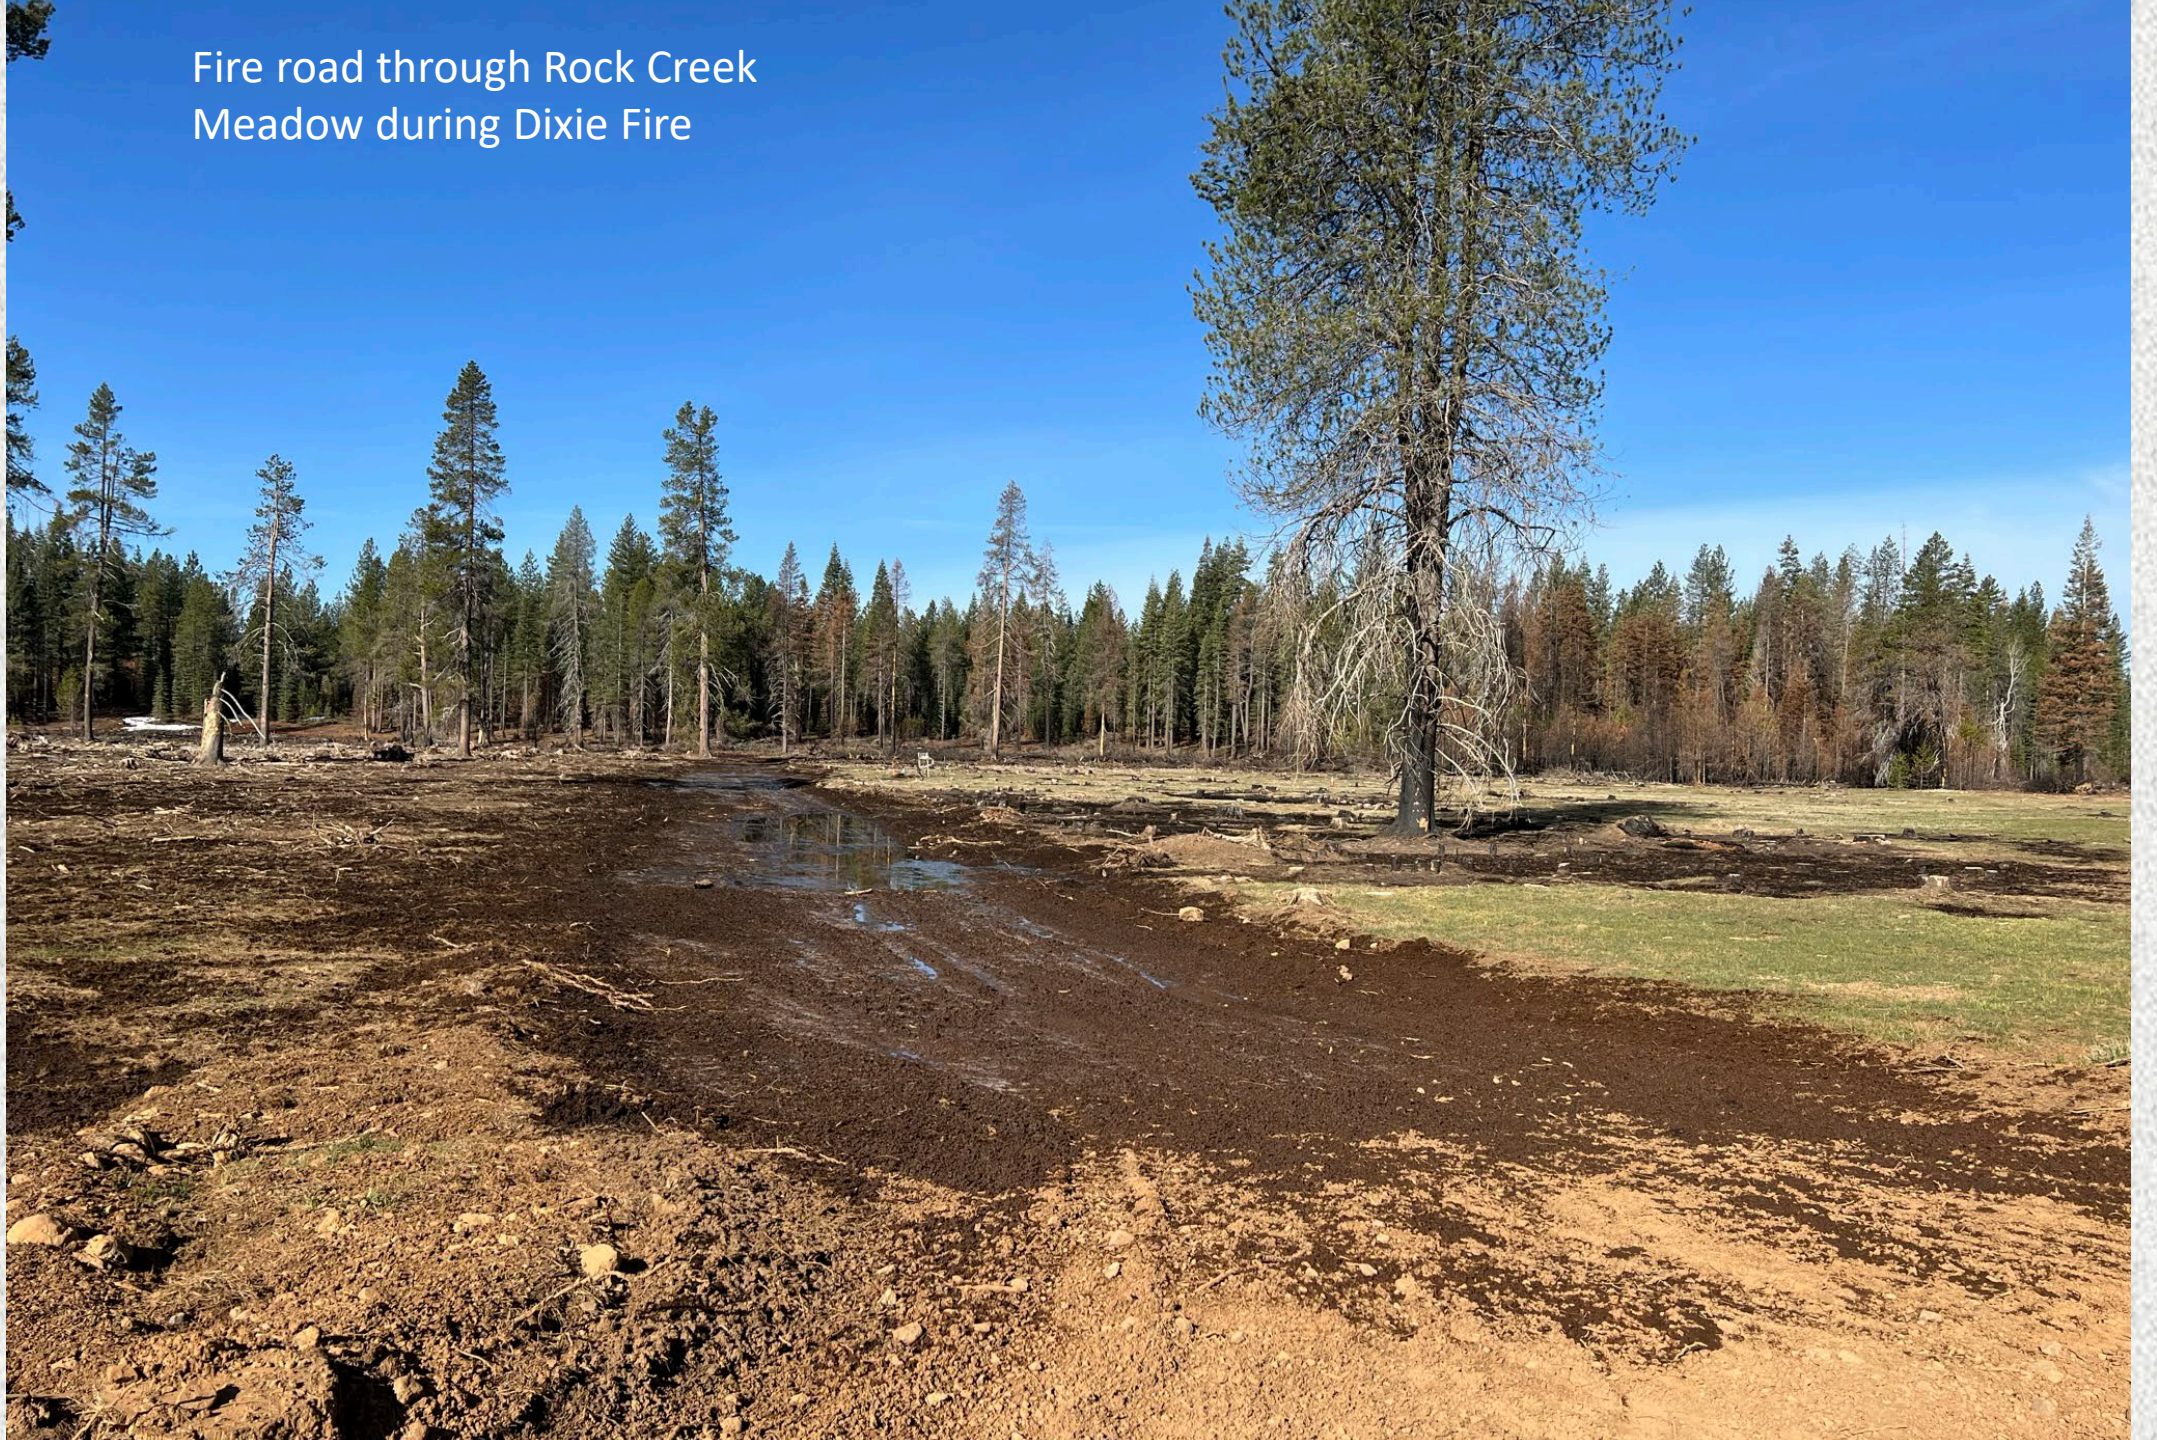
Dixie Fire Effect
2021

Fire road through Rock Creek
Meadow during Dixie Fire

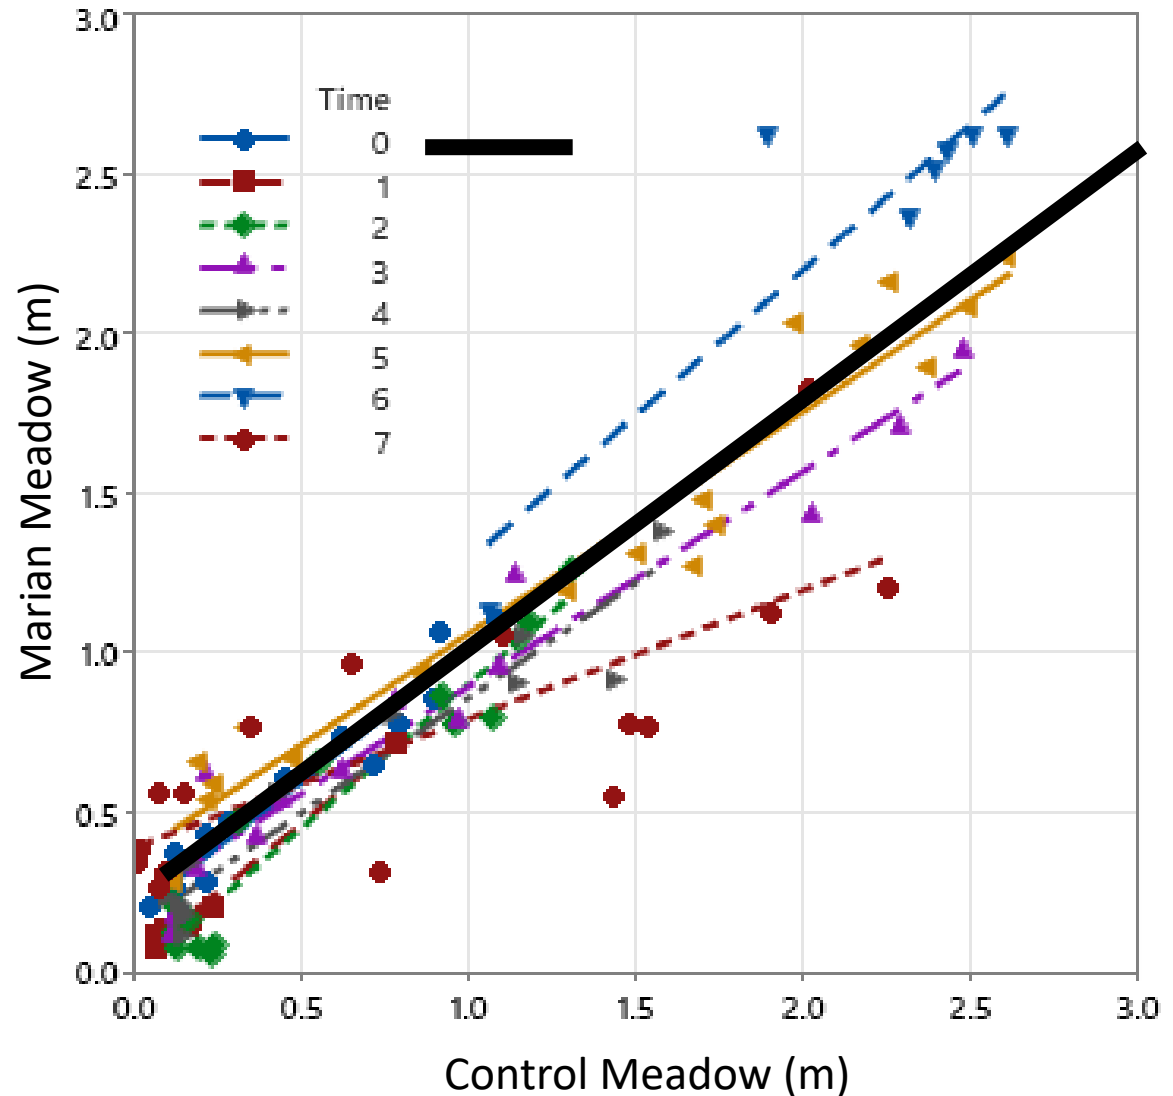
Depth to Groundwater

Marian Meadow Study 2013-2022

- Increase in groundwater in Marian Meadow following conifer removal, except for 2020-2021.
- Average 0.06 m increase in groundwater depth
- Increase attributed to loss of interception from removal of encroached conifer (Surfleet et al., 2020).

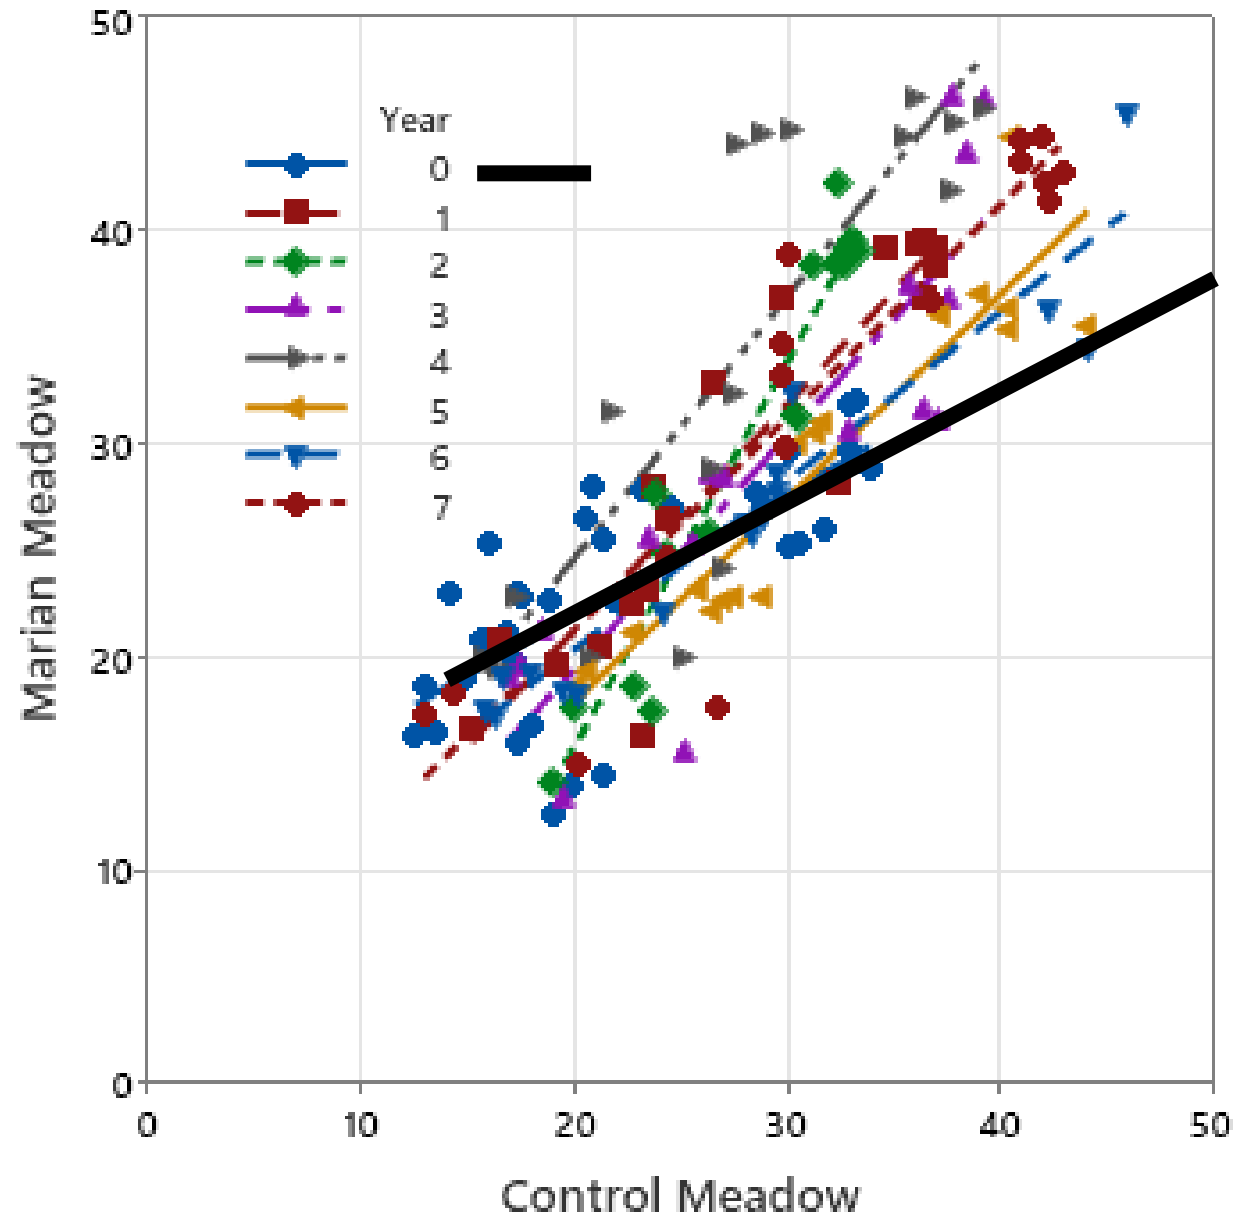
Marian Meadow Study 2013-2022

- Increase in shallow soil moisture in wet season.
- Decrease in soil moisture in dry season in years directly after tree removal.
- Decrease attributed to loss of shade cover or increased transpiration of meadow vegetation from removal of encroached conifers.

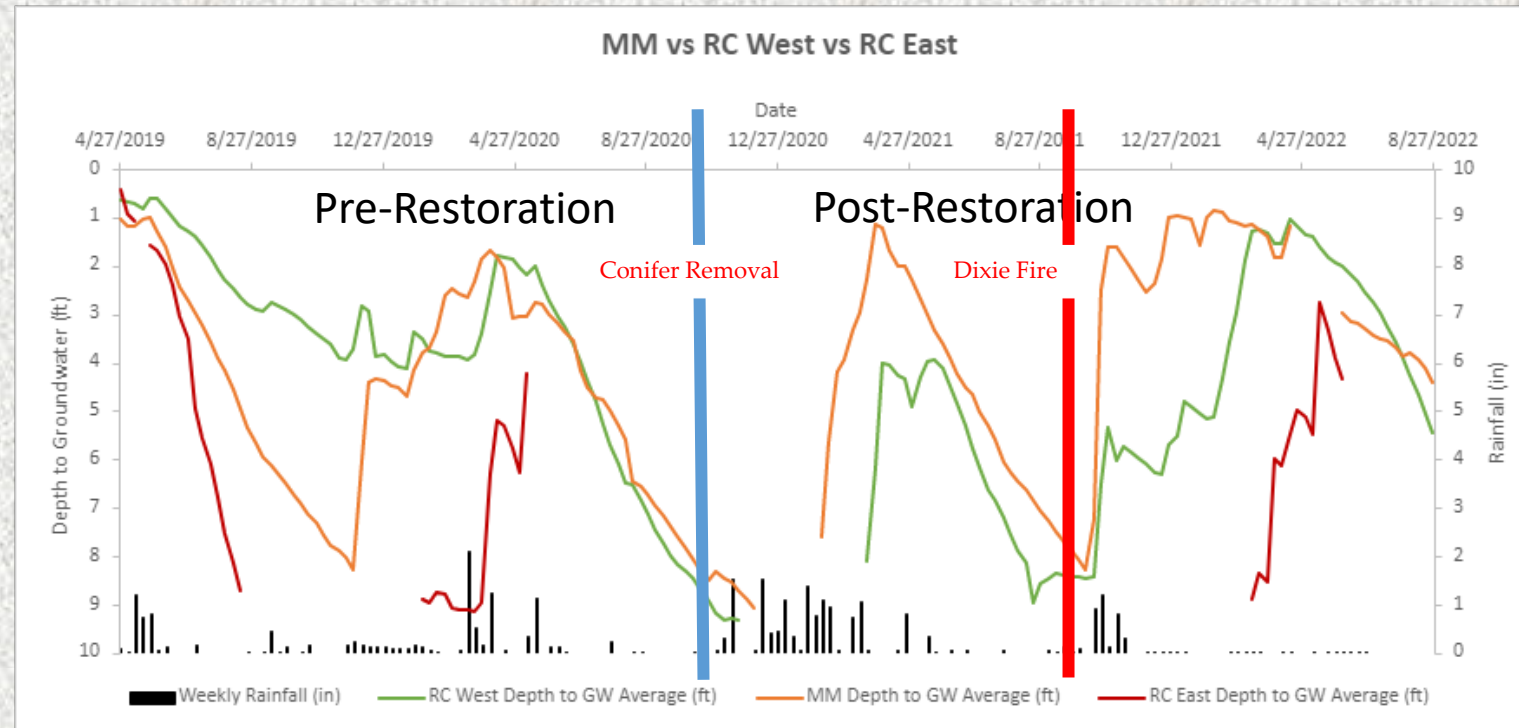
Depth to Groundwater

Rock Creek Meadow Study 2019-2022

- No statistical difference in groundwater 2nd year following restoration.
- First year decrease in groundwater. This was a drought year

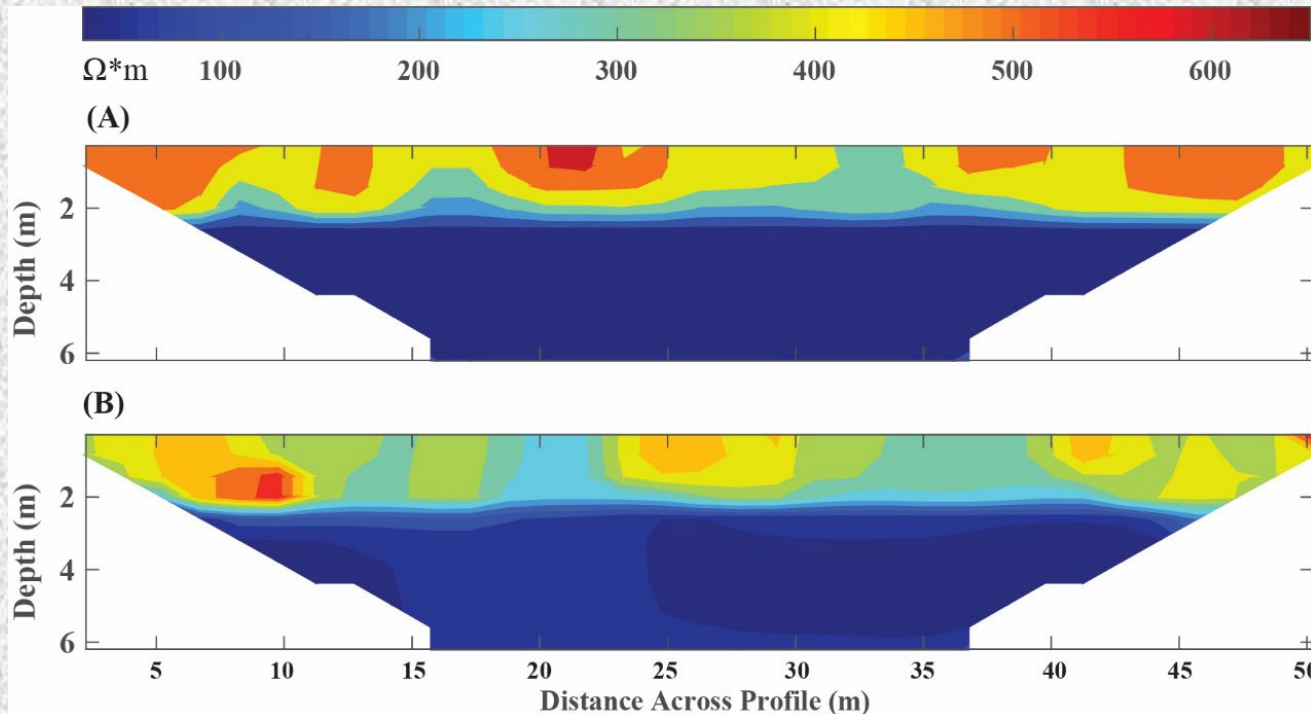
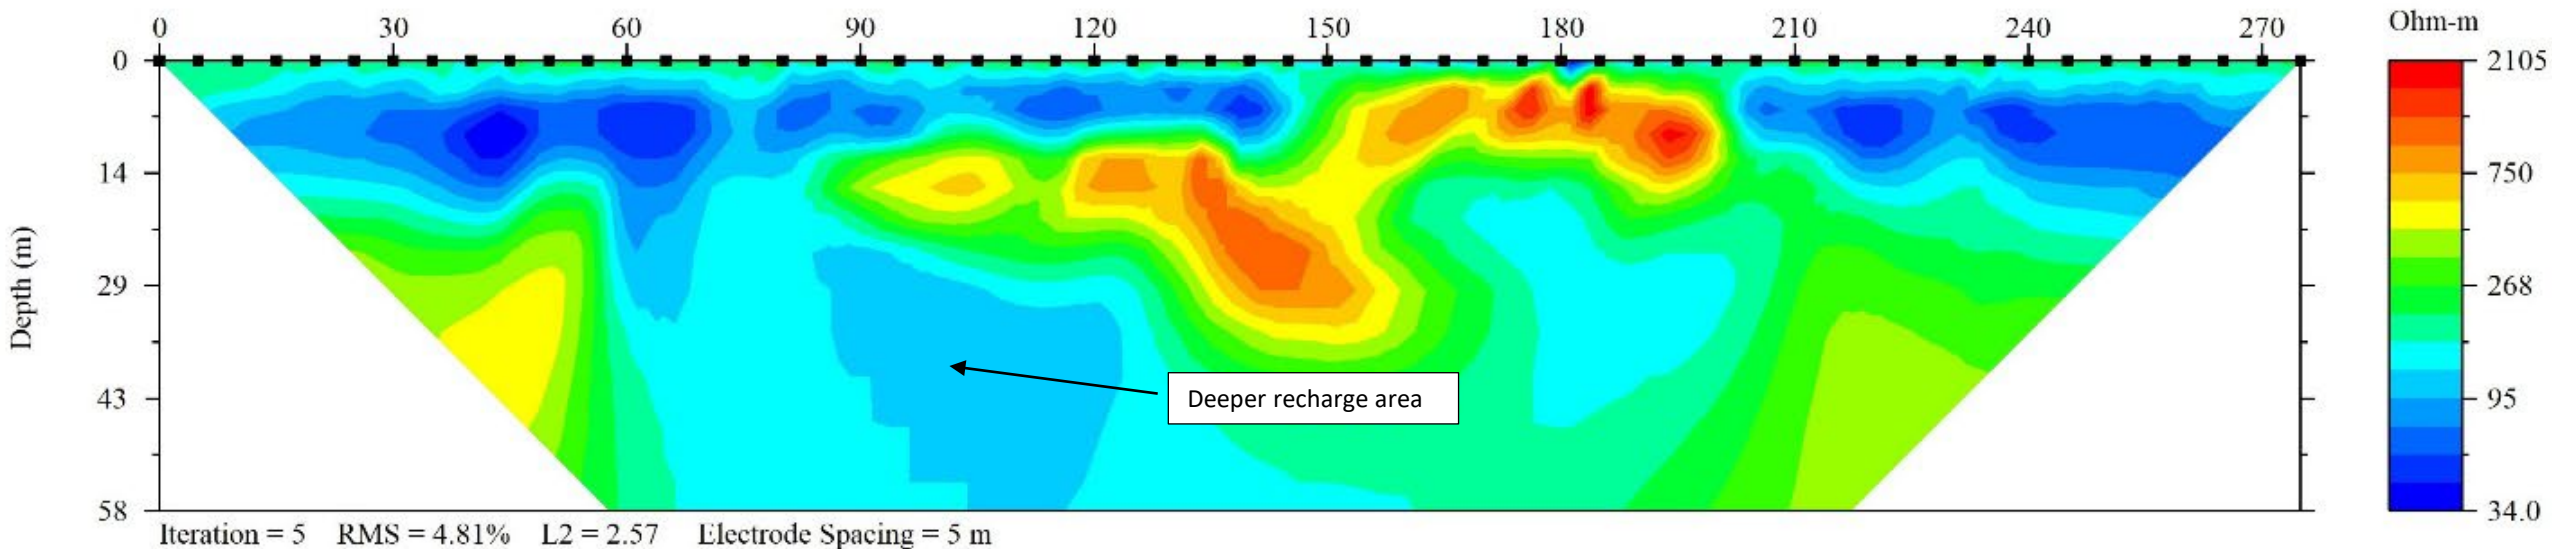
Electroresistivity Tomography

Marian Meadow

Rock Creek Meadow

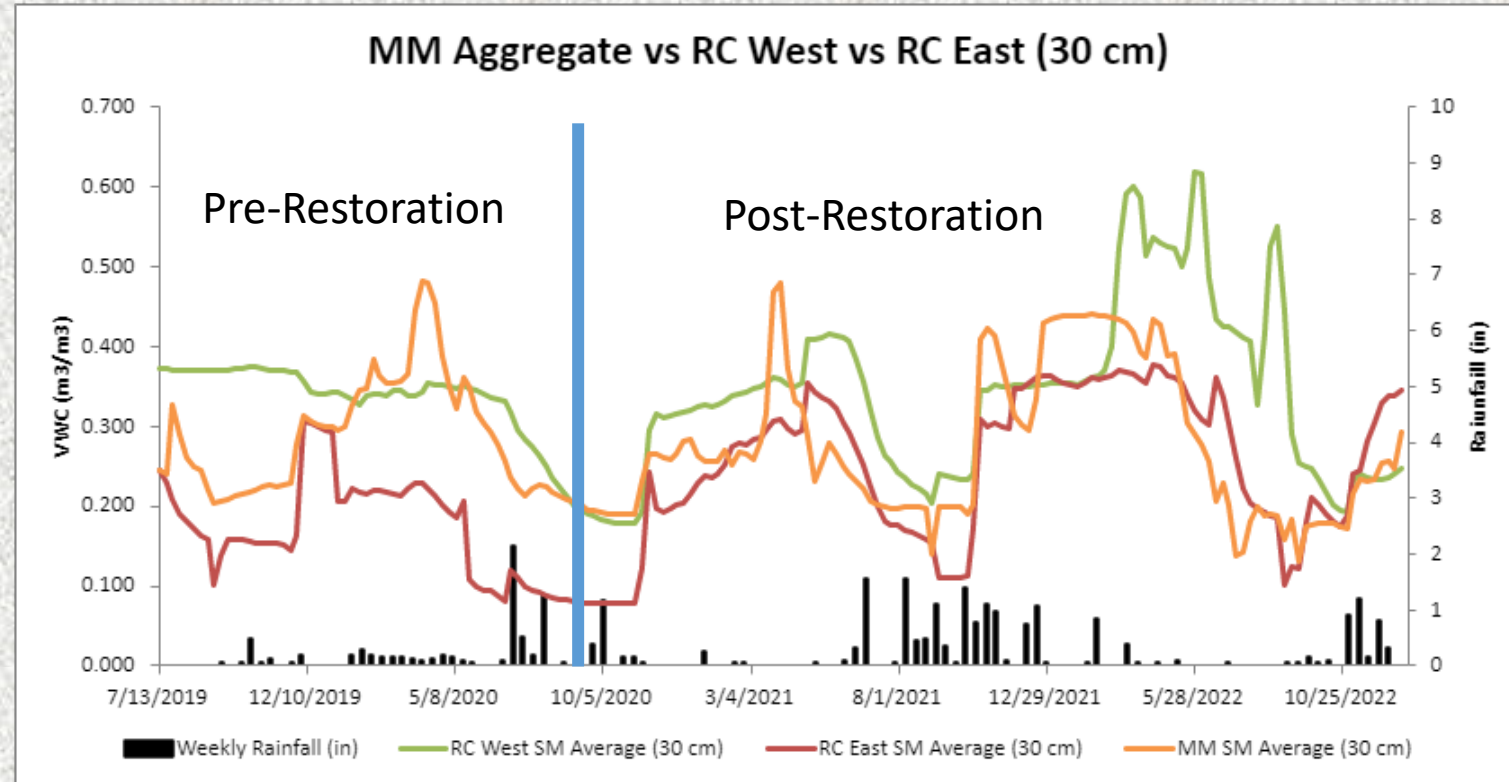
Preliminary Results

Rock Creek Meadow Study 2019-2022

- Increased soil moisture in Rock Creek following *Pinus Contorta* removal.
- *Pinus Contorta* transpiration 200-300 mm/yr.

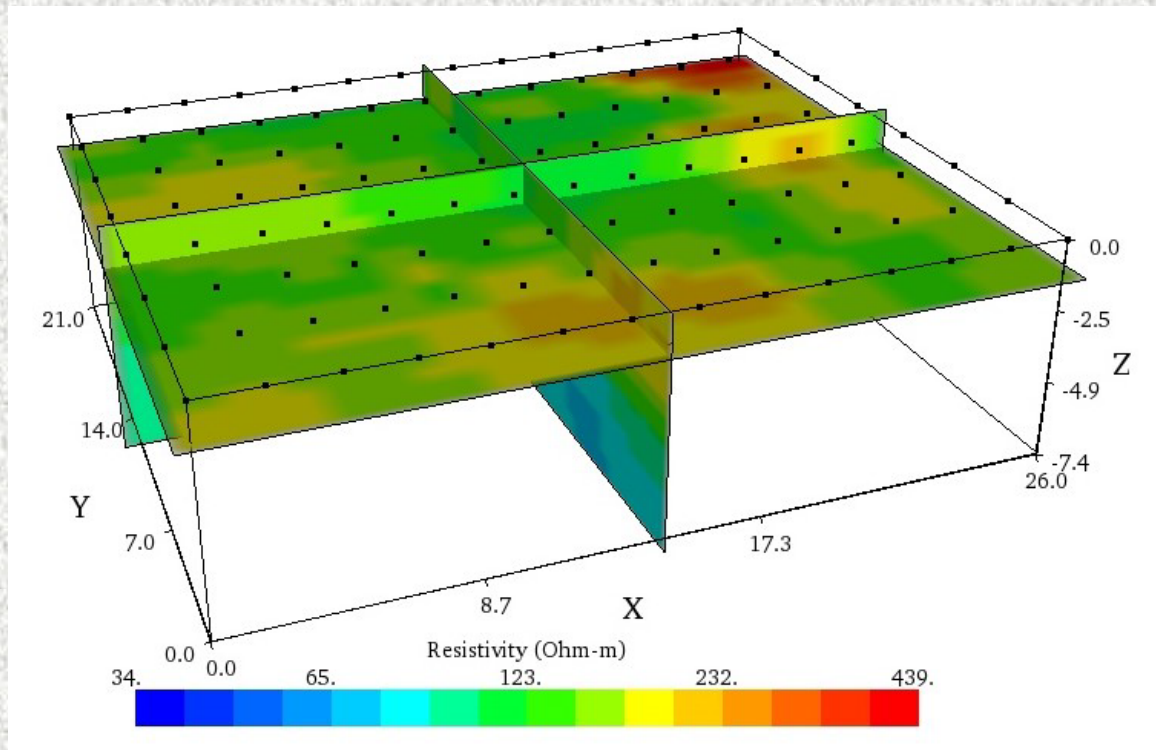
2020 pre-restoration

Three Dimensional Images of Electrical Resistivity

Rock Creek Meadow – Site 2

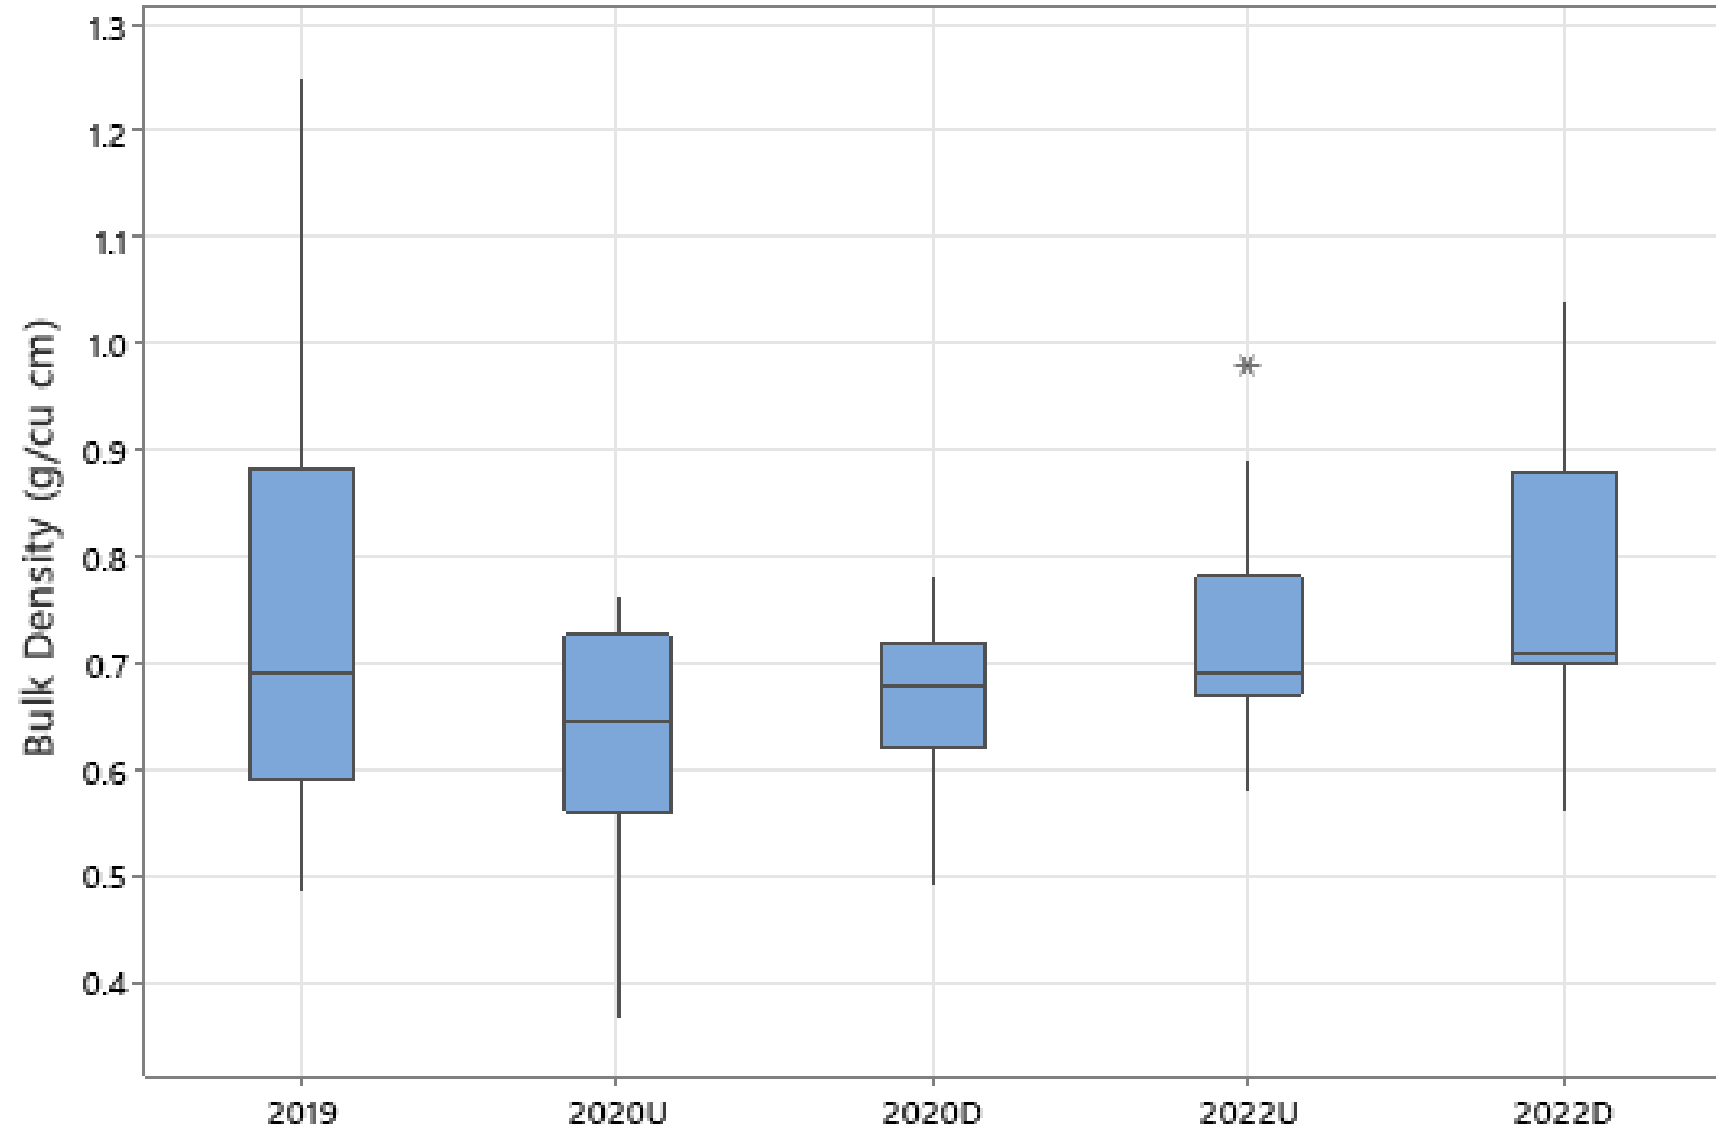
Soil Bulk Density in the WLPZ

No statistical difference

- Low soil moisture
- Limits on equipment in WLPZ
- High organic matter in soil

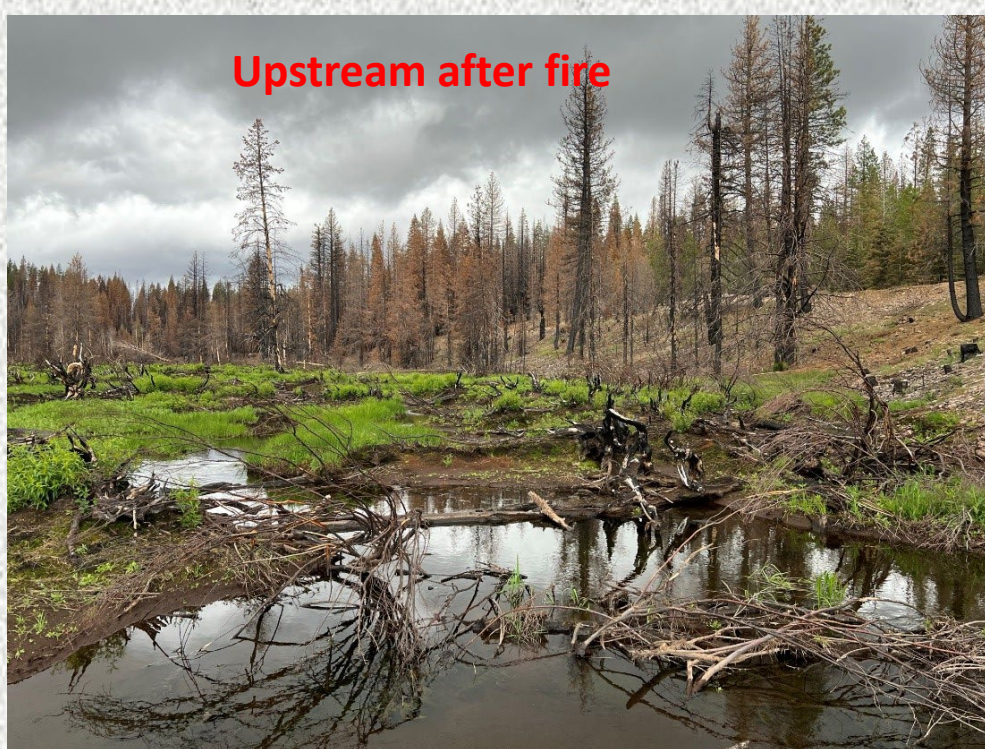
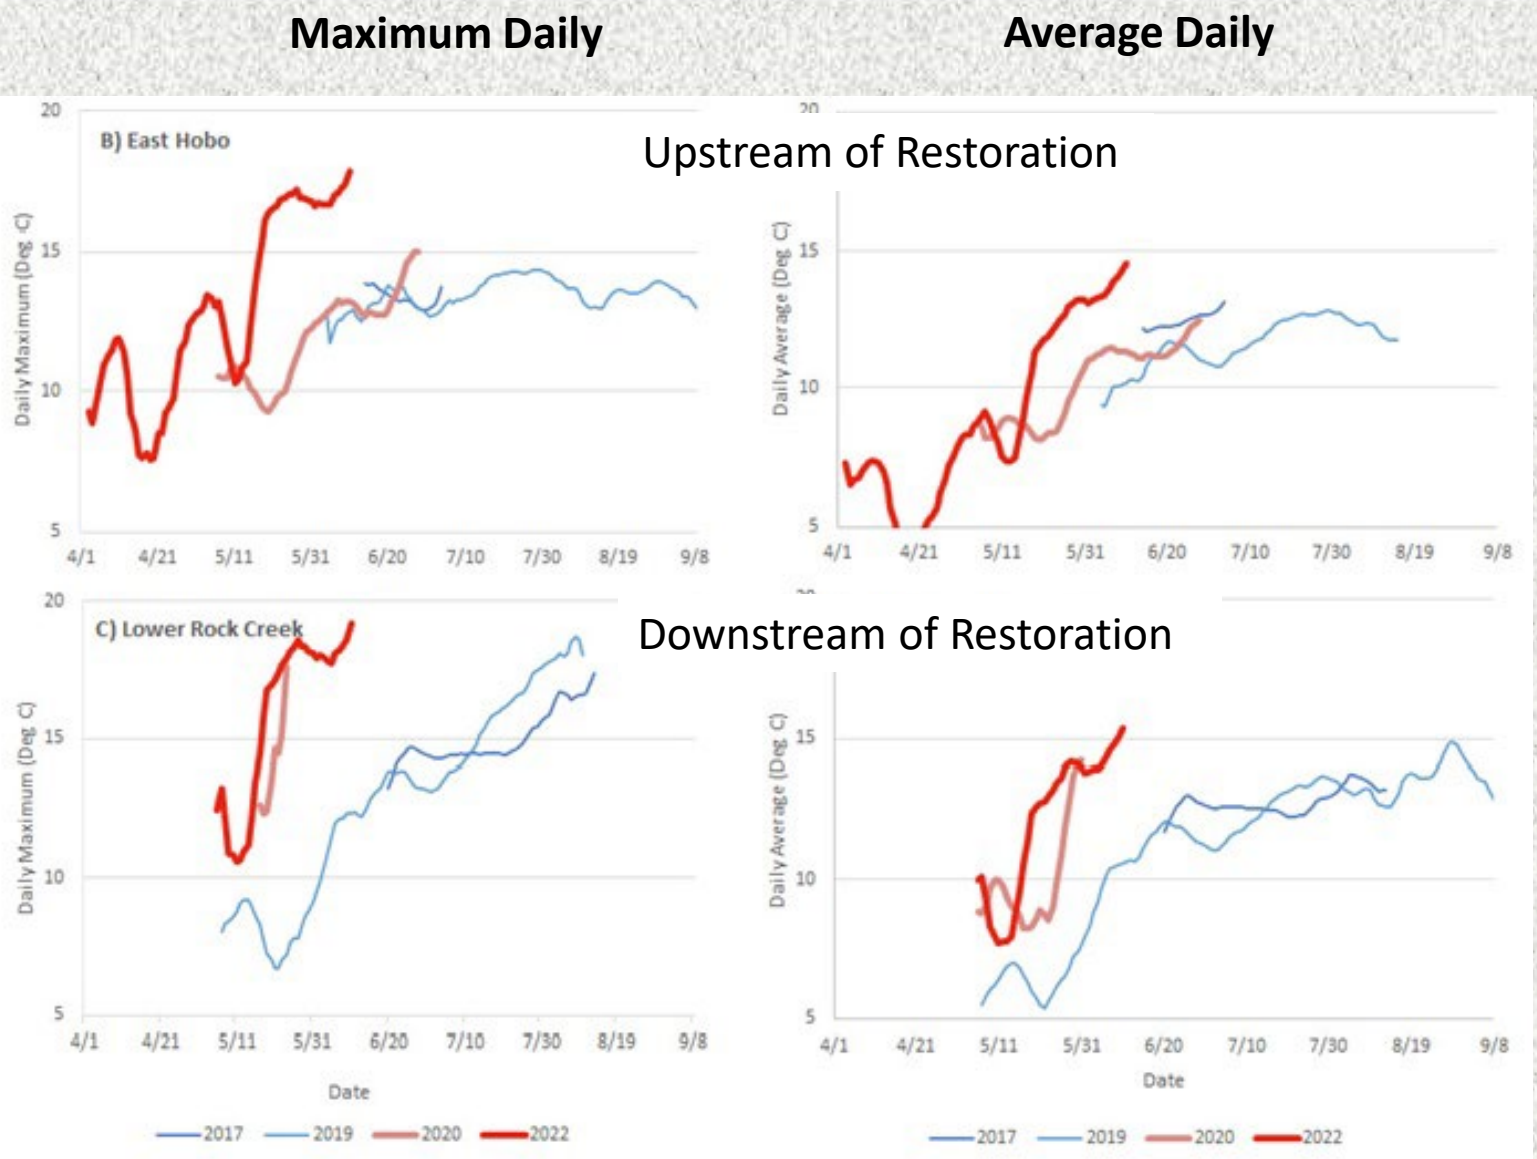
Stream Habitat Response

- Before
- After
- After Fire

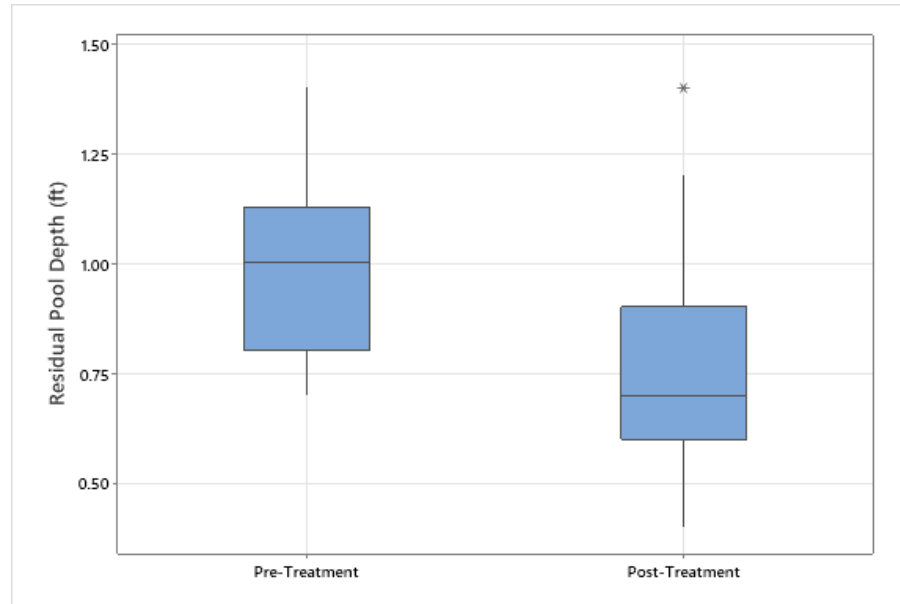
Stream Habitat Response

Slight decrease in pool habitat and pool depths following restoration and fire.

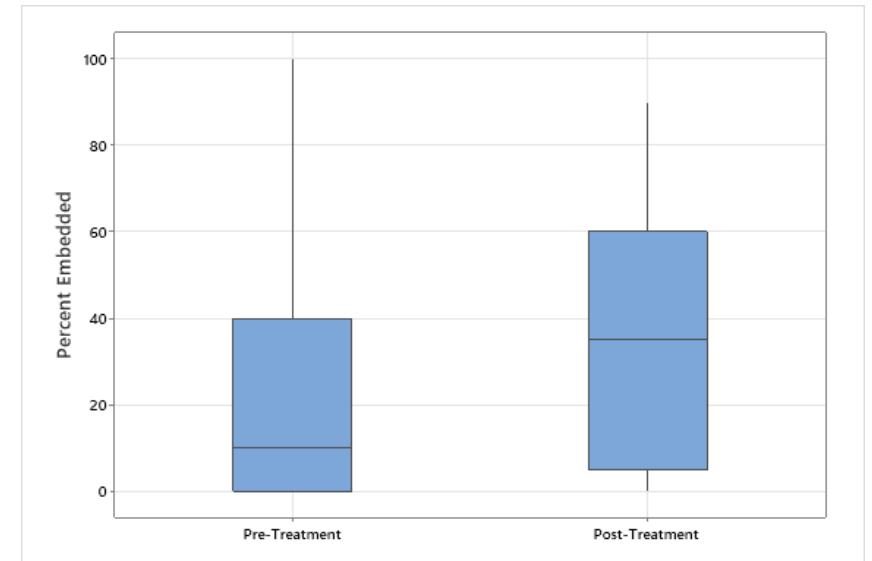
Stream bed had slightly higher embeddedness following restoration and fire

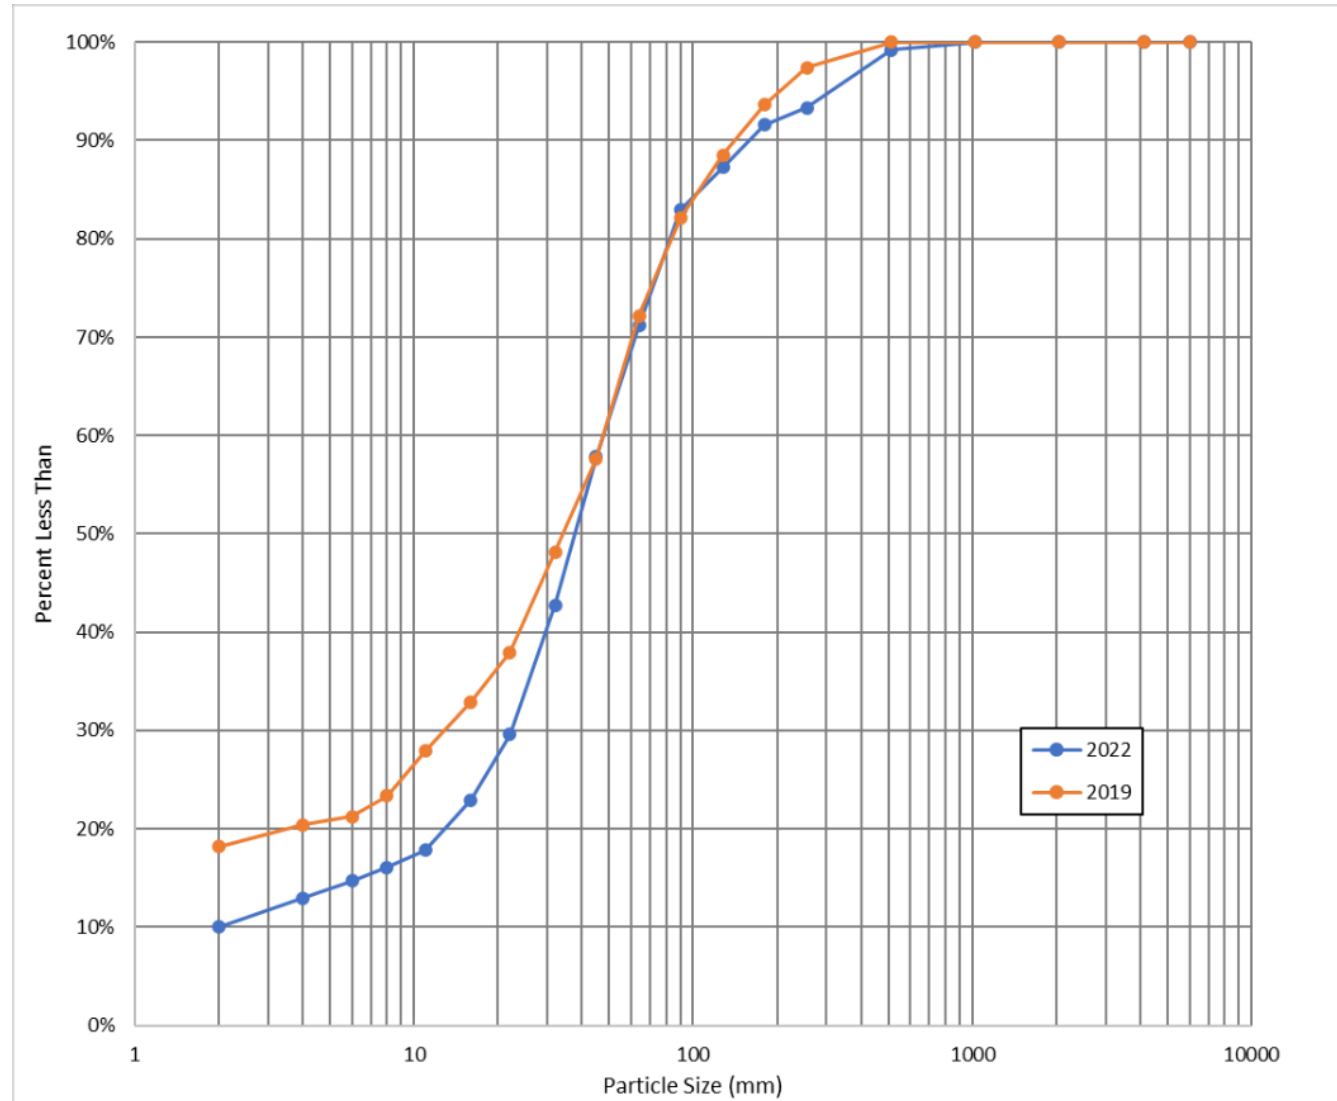
Stream Habitat Response

Increased fine sediments
following restoration and
fire
